## Work Order Photo Album

6950 Nova Way

Work Order #: 3644

6950 Nova Way Manassas VA 20109  
LaQuinta roof inspection report 7/16/26

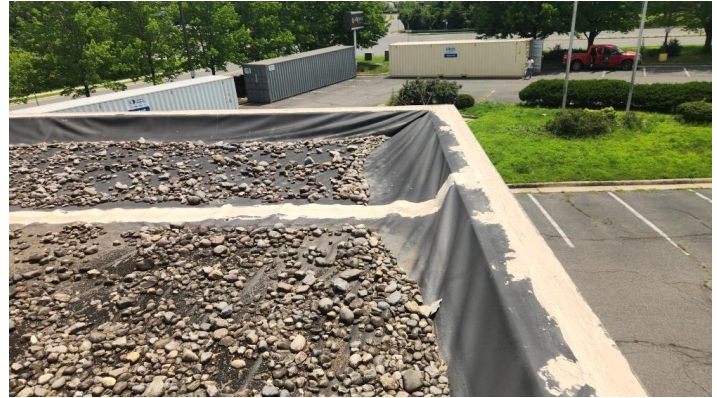
Overview  
Of front canopy roof

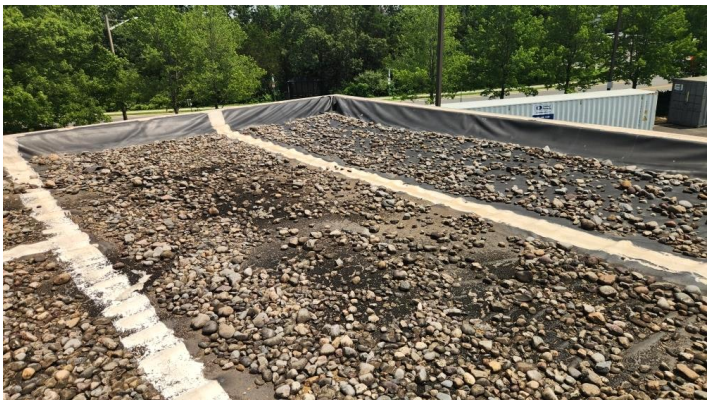
Overview  
Of front canopy roof

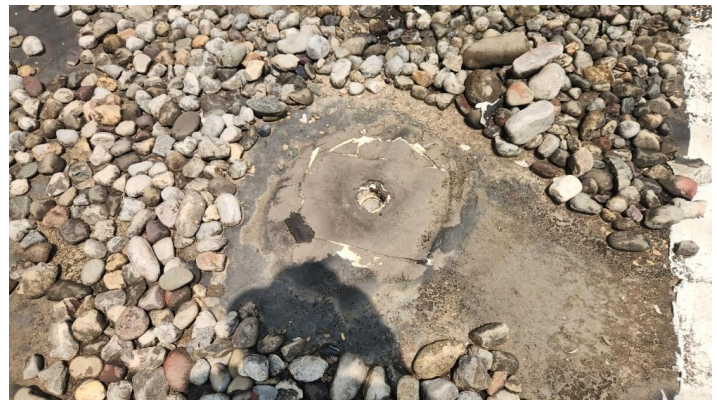
Drain- deteriorated membrane  
The flashing membrane is deteriorated and should be replaced to avoid further degradation.

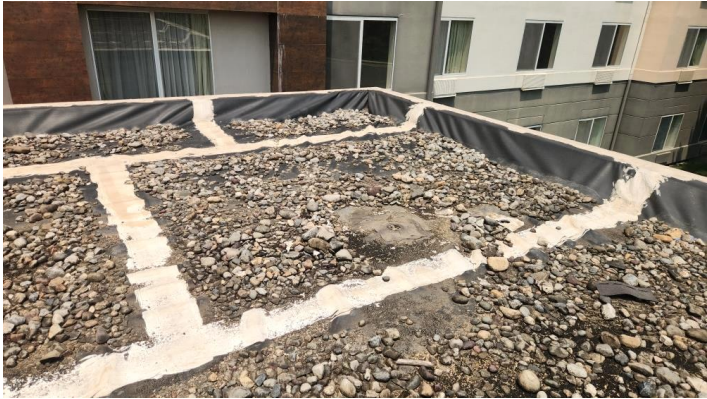
### Base Flashing- delaminated

Flashing has delaminated from vertical substrate. Slippage and wrinkling are signs of delamination.

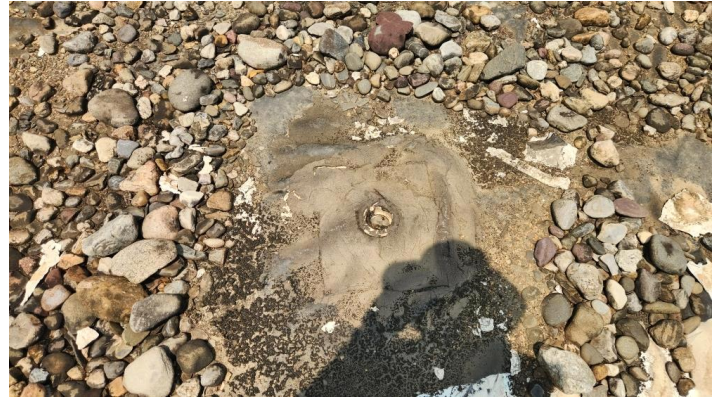
### Drain- deteriorated membrane

The flashing membrane is deteriorated and should be replaced to avoid further degradation.

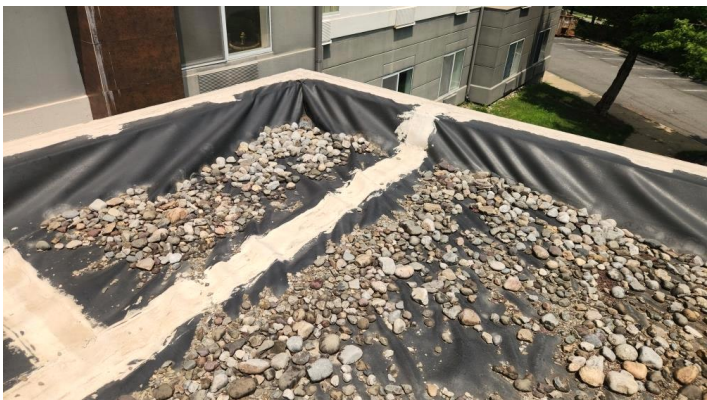
### Base Flashing- delaminated

Flashing has delaminated from vertical substrate. Slippage and wrinkling are signs of delamination.

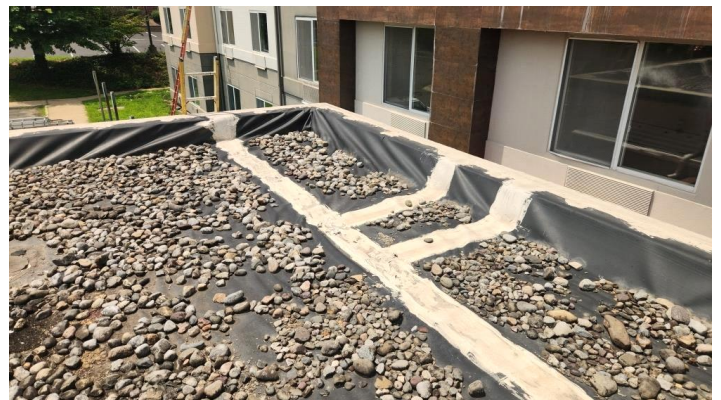
### Base Flashing- delaminated

This flat canopy roof is in bad shape and needs to be replaced

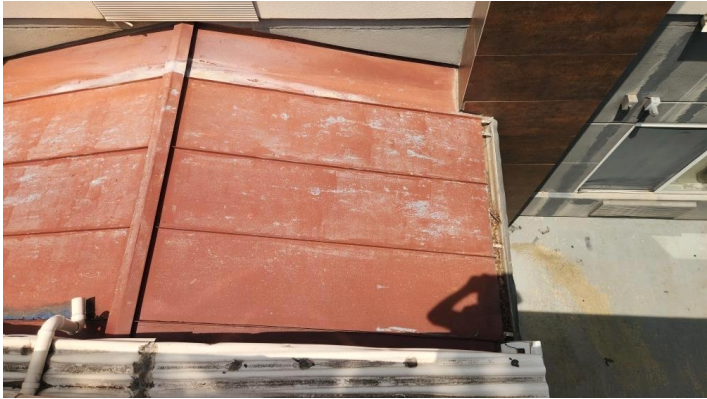
Small metal roof  
Needs to be replaced and crickets installed where missing

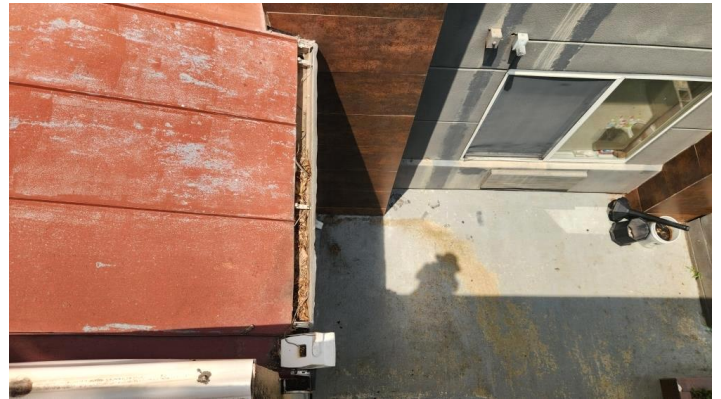
Gutter full of debris

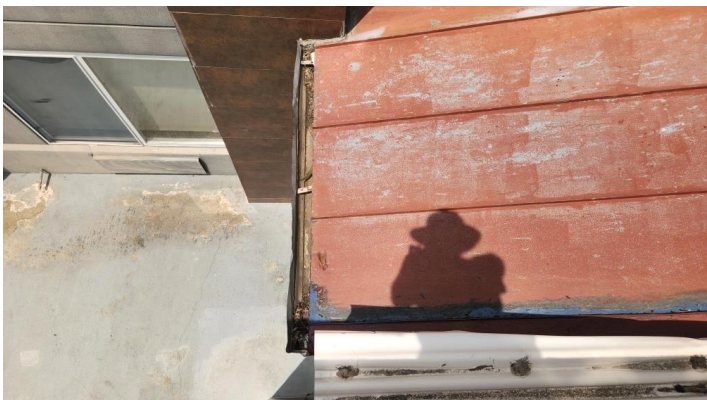
Gutter debris should be removed

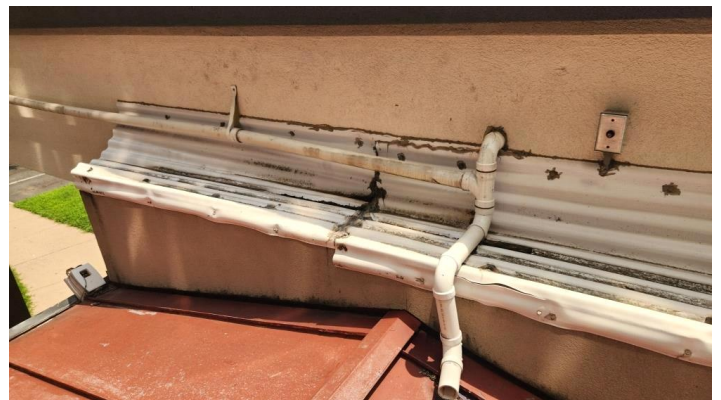
Drain pipes from front flat roof

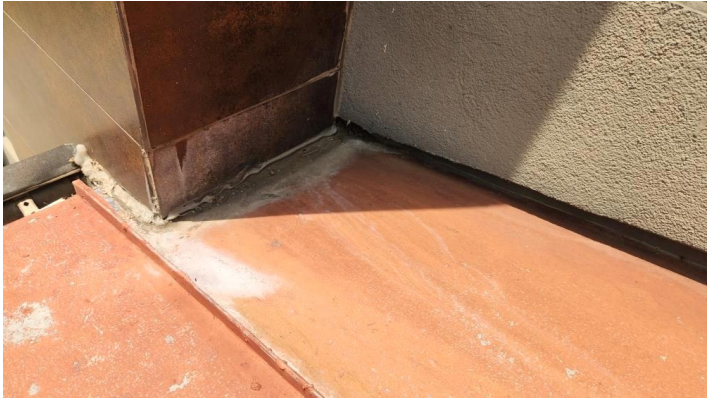
Missing cricket to divert water away from the wall

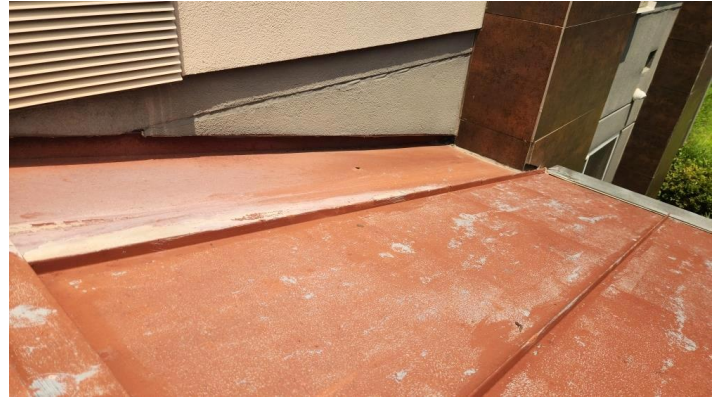
Missing cricket to divert water away from the wall

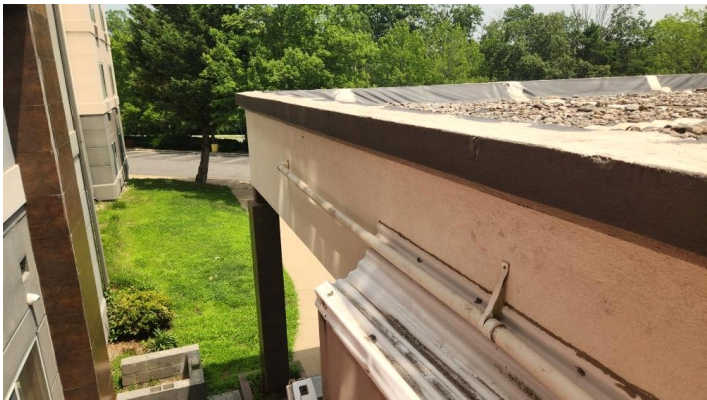
Drain pipes from front flat roof

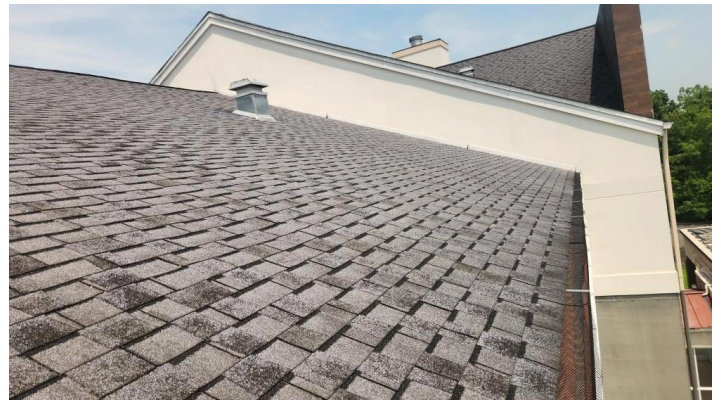
Shingles are in bad shape with alot of granular loss  
The shingle roofs need to be replaced

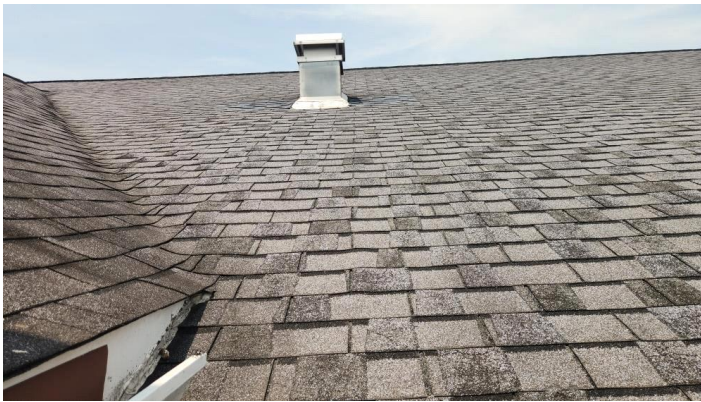
Shingles are in bad shape with alot of granular loss  
The shingle roofs need to be replaced

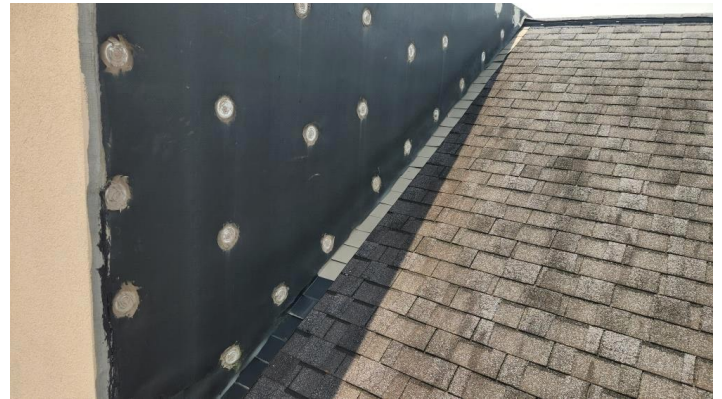
Improper flashing detail  
Step flashing is installed wrong at bottom of wall and  
improper wall flashing with holes and fasteners everywhere

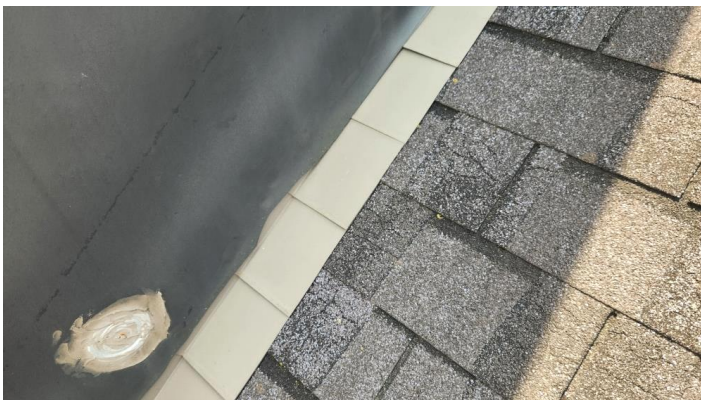
Improper flashing detail  
Step flashing is installed wrong at bottom of wall and  
improper wall flashing with holes and fasteners everywhere

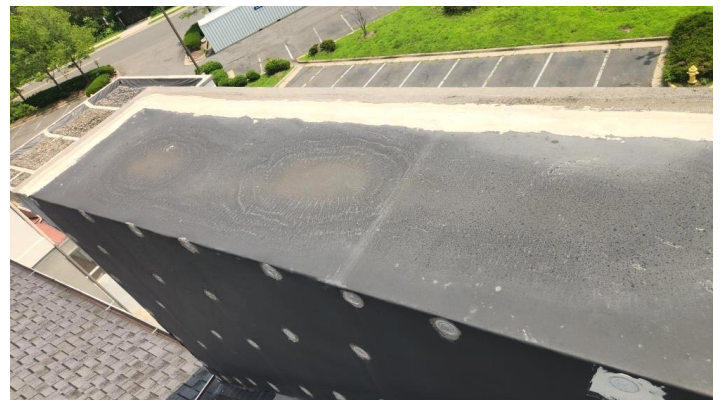
Improper flashing detail  
Step flashing is installed wrong at bottom of wall and  
improper wall flashing with holes and fasteners everywhere

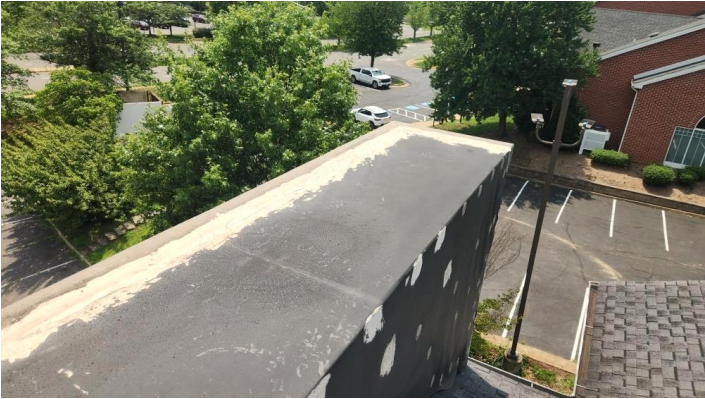
Improper flashing detail  
The roof needs to be replaced

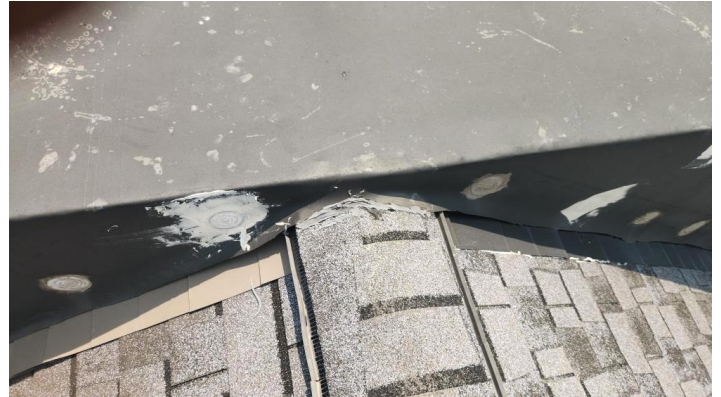
Field- improper repair  
Step flashing is installed wrong at bottom of wall and improper wall flashing with holes and fasteners everywhere

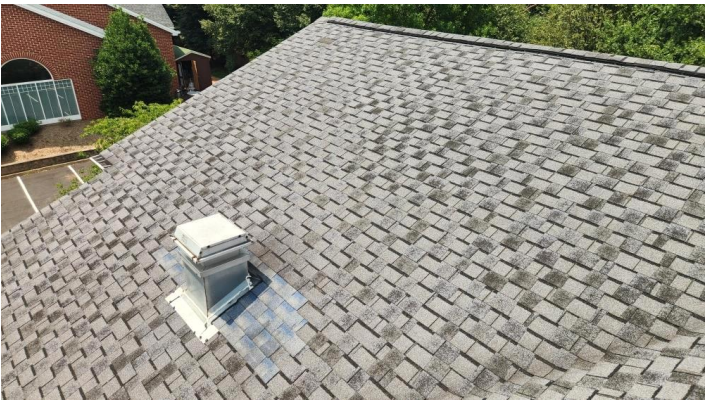
Shingles are in bad shape with alot of granular loss  
Prior repair by others

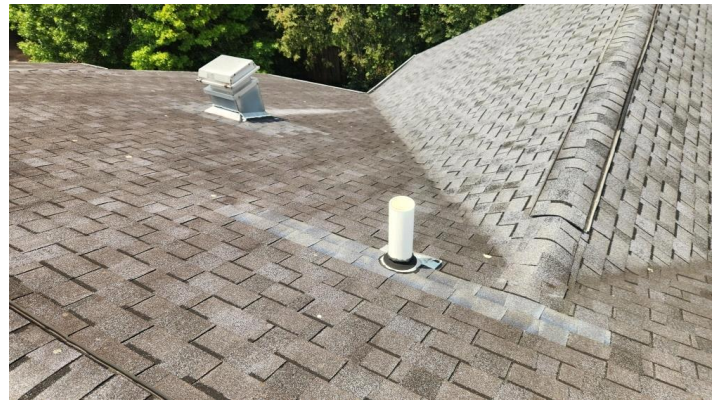
Shingles are in bad shape with alot of granular loss  
Prior repair by others

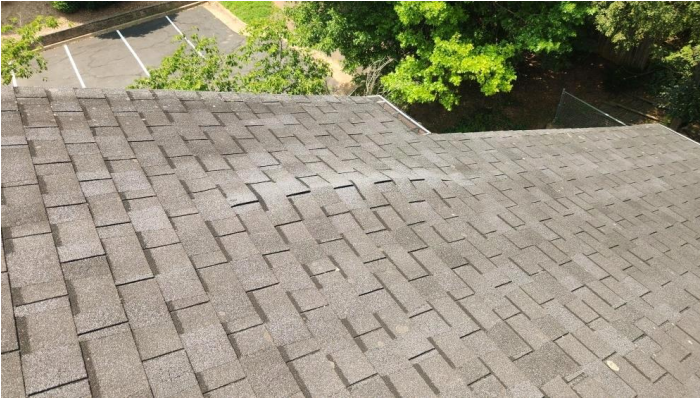
Bowed plywood  
Plywood needs to be replaced and new shingles installed

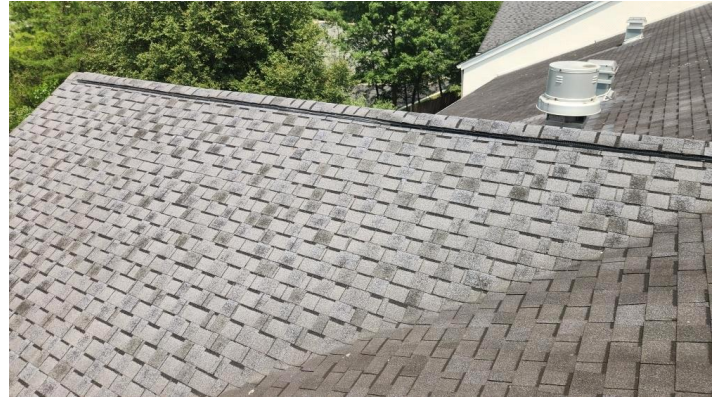
Shingles are in bad shape with alot of granular loss  
The shingle roofs need to be replaced

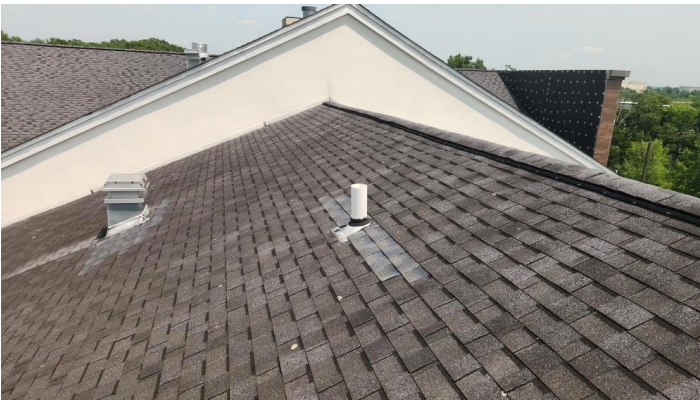
Shingles are in bad shape with alot of granular loss  
Prior repair by others

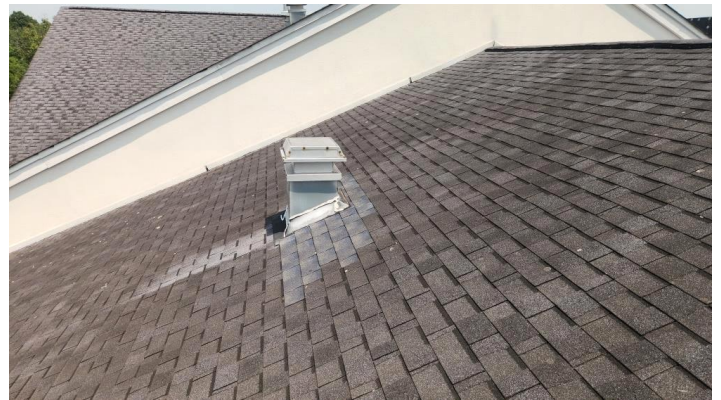
Shingles are in bad shape with alot of granular loss  
Prior repair by others

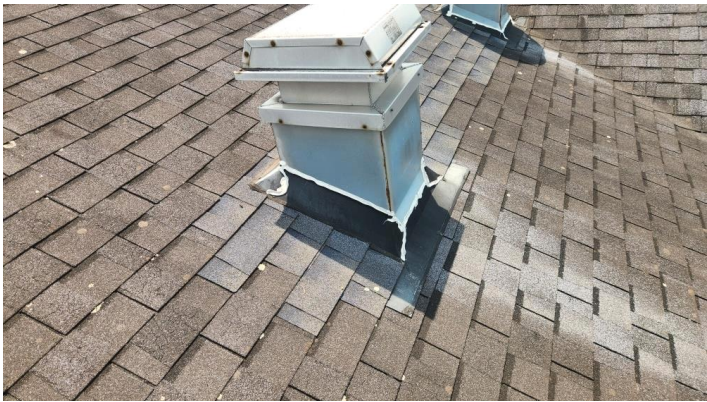
Shingles are in bad shape with alot of granular loss  
Prior repair by others

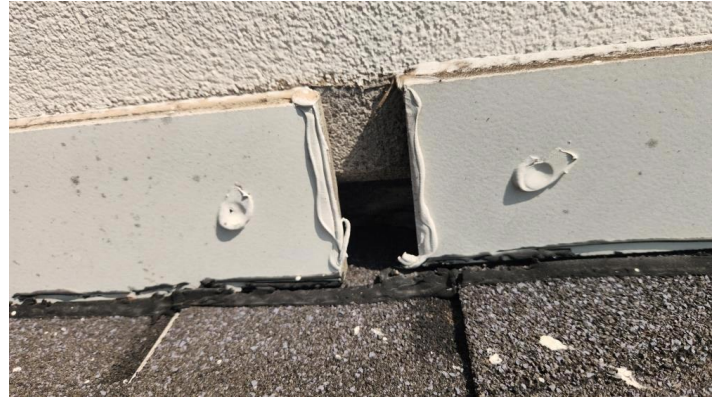
Improper flashing detail  
Missing step flashing and gap in flashing

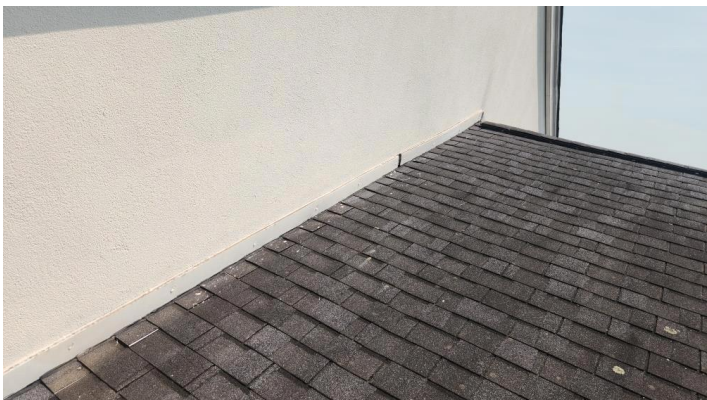
Improper flashing detail  
Missing step flashing and gap in flashing

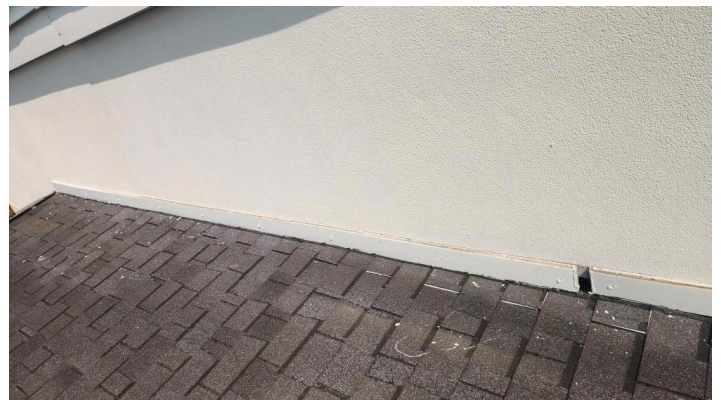
Improper flashing detail  
Missing step flashing and gap in flashing

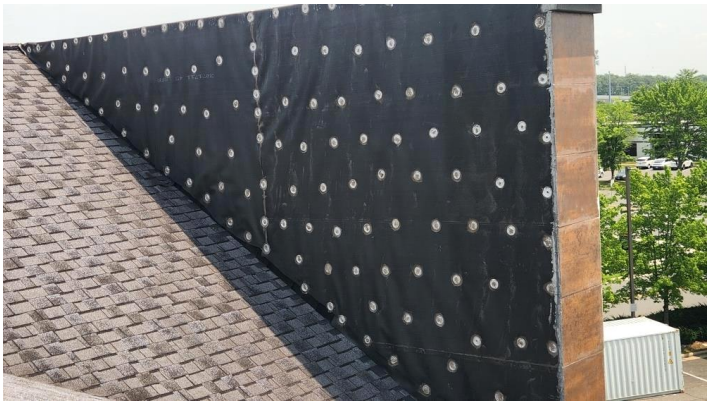
### Improper flashing detail

Step flashing missing at bottom of wall and improper wall flashing with holes and fasteners everywhere

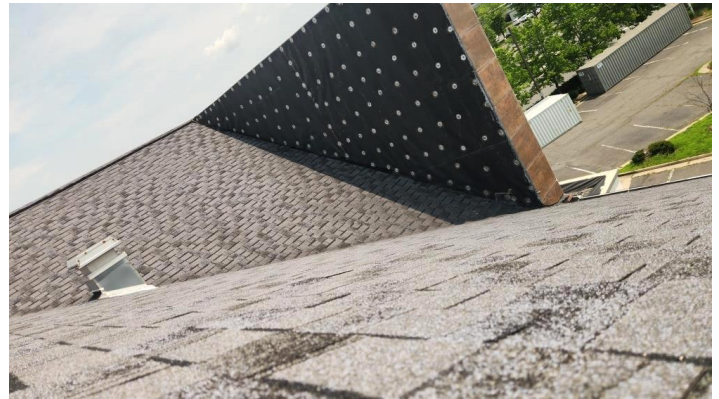
### Improper flashing detail

Step flashing missing at bottom of wall and improper wall flashing with holes and fasteners everywhere

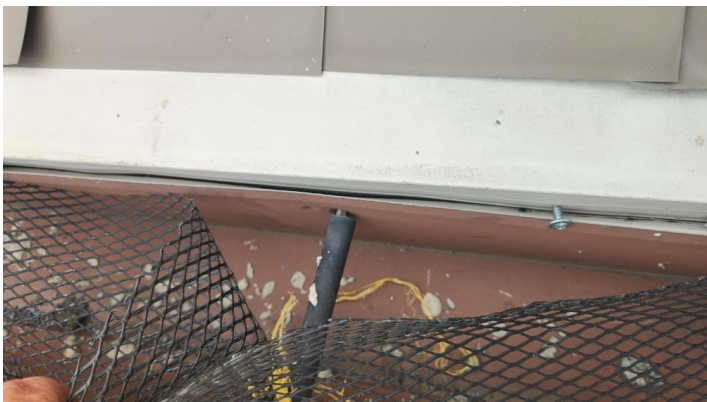
### Gutters are loose

New hidden hangers should be installed to tighten up the gutter

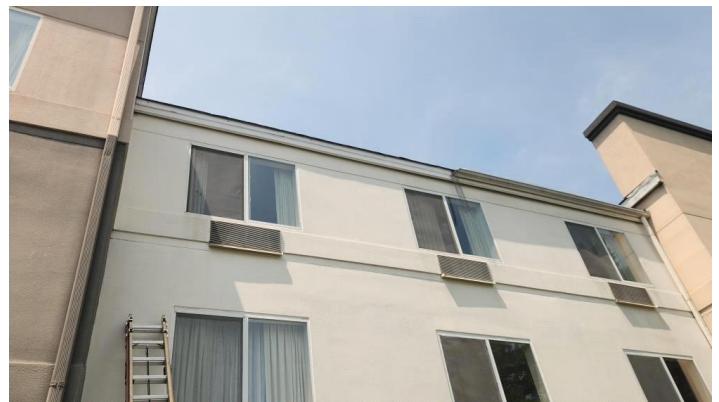
### Broken missing gutter

New gutter needs to be installed

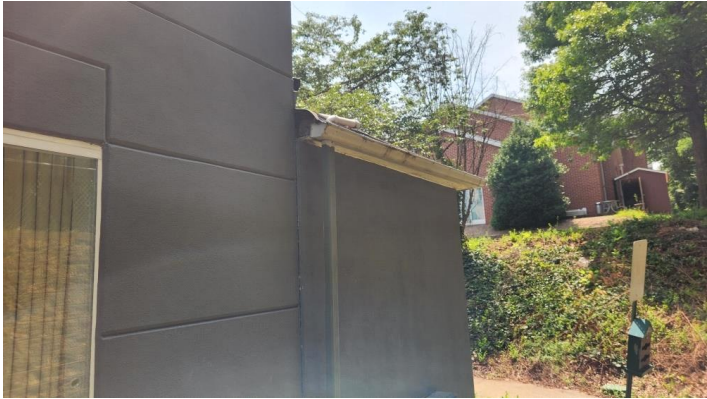
Missing fascia trim & rotted subframing  
New trim needs to be installed after framing repairs are made

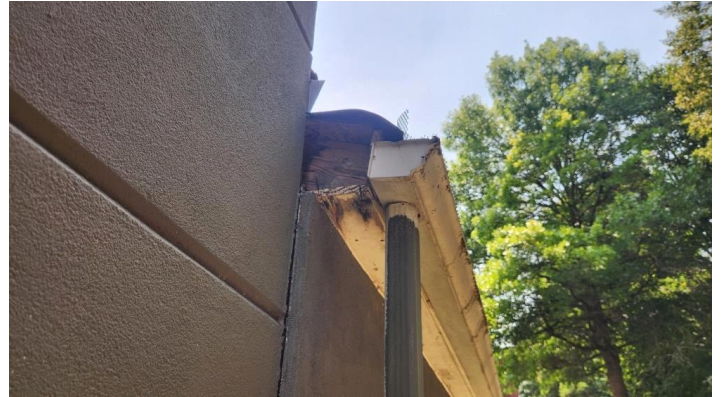
Missing fascia trim & rotted subframing  
New trim needs to be installed after framing repairs are made

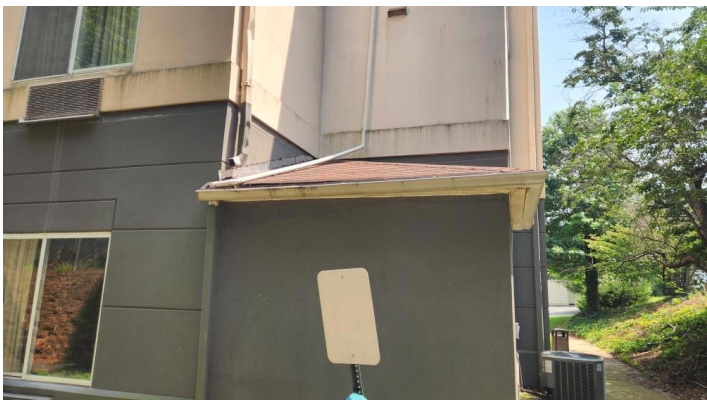
Improper flashing detail  
Missing step flashing and gap in flashing

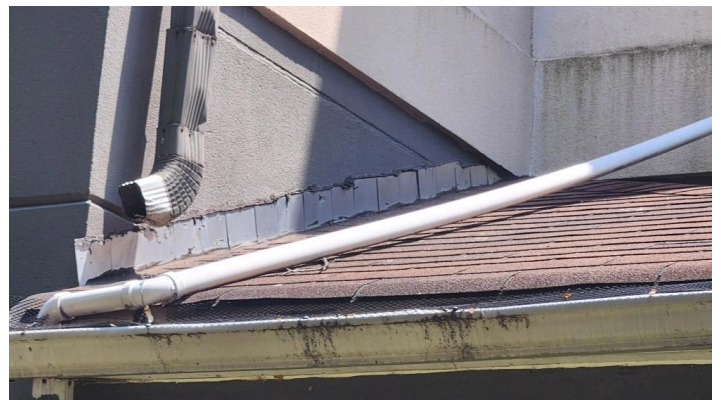
Improper flashing detail  
Missing step flashing and gap in flashing

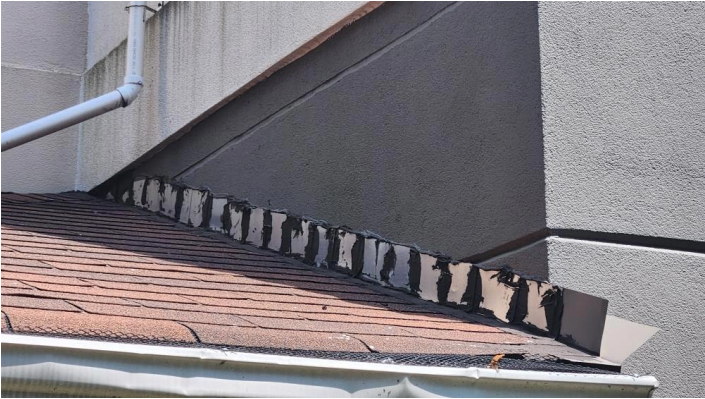
Improper flashing detail  
Missing step flashing and gap in flashing

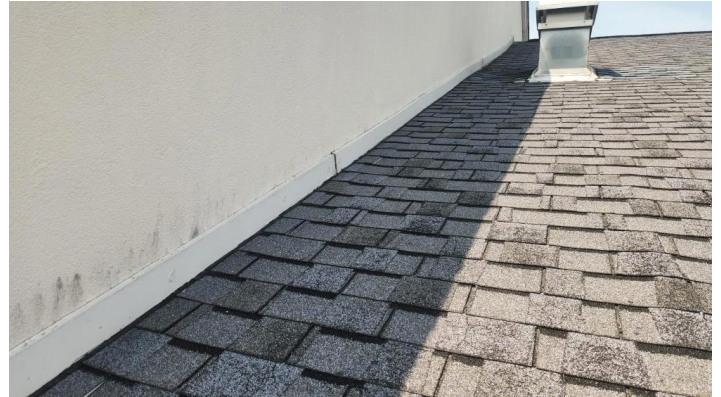
Improper flashing detail  
Missing step flashing and gap in flashing

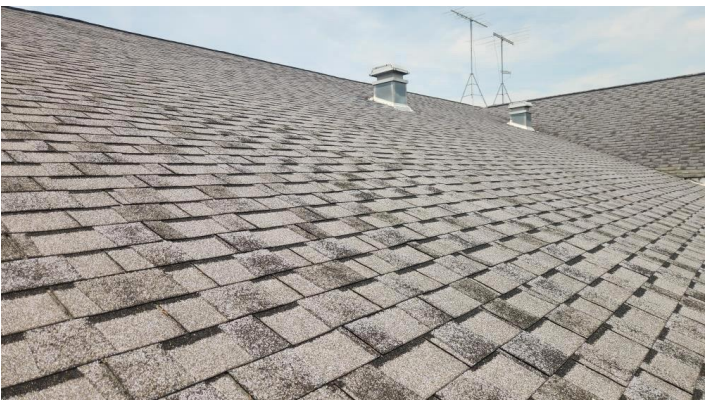
Shingles are in bad shape with alot of granular loss  
The shingle roofs need to be replaced

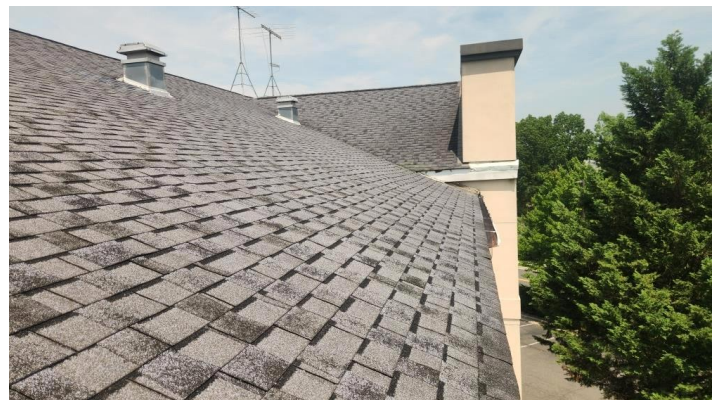
Shingles are in bad shape with alot of granular loss  
The shingle roofs need to be replaced

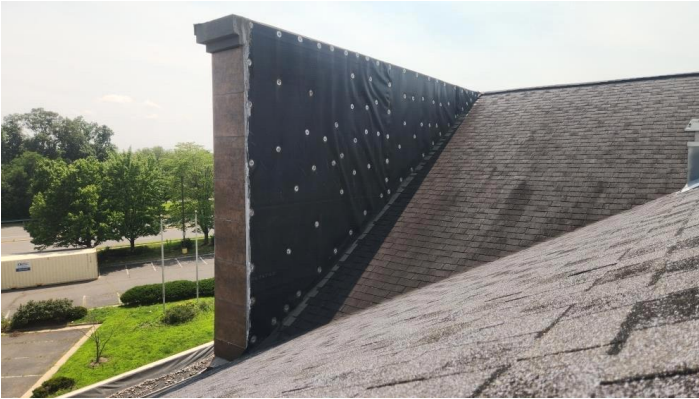
### Improper flashing detail

Step flashing is installed wrong at bottom of wall and improper wall flashing with holes and fasteners everywhere

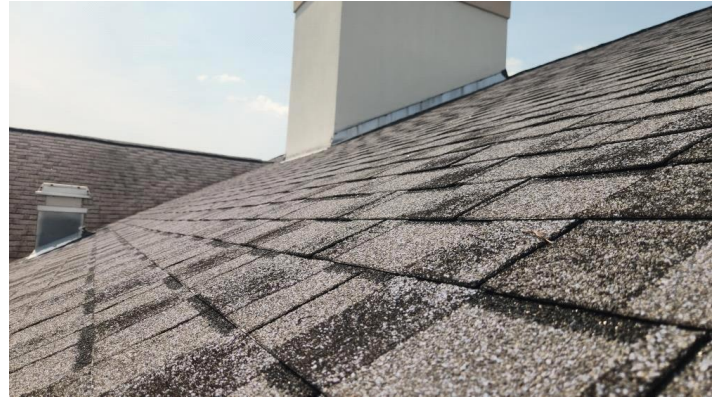
Shingles are in bad shape with alot of granular loss  
The shingle roofs need to be replaced

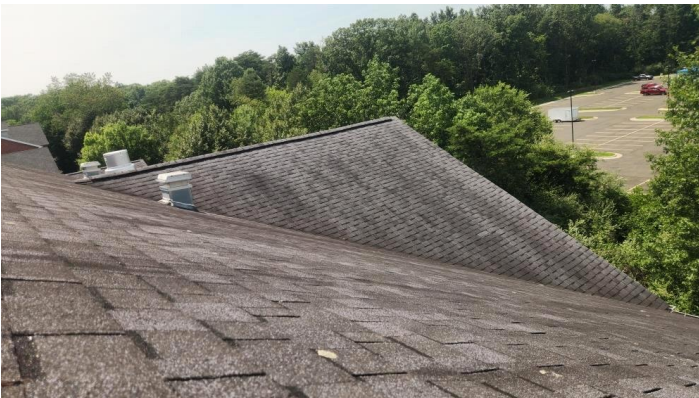
Shingles are in bad shape with alot of granular loss  
The shingle roofs need to be replaced

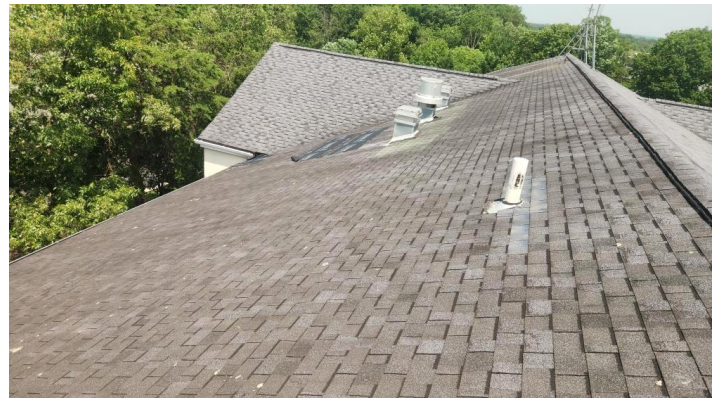
Shingles are in bad shape with alot of granular loss  
The shingle roofs need to be replaced

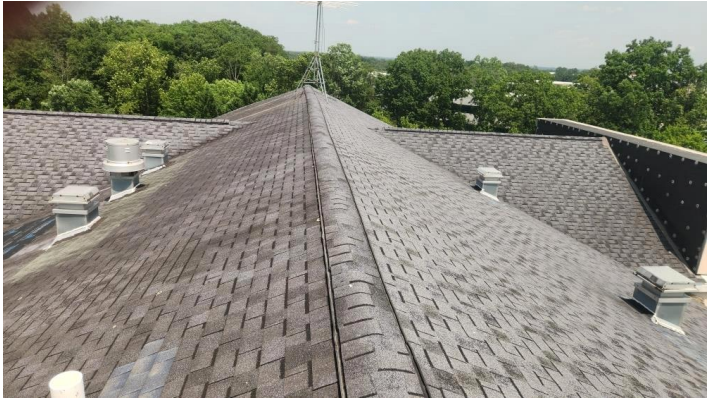
Shingles are in bad shape with alot of granular loss  
The shingle roofs need to be replaced

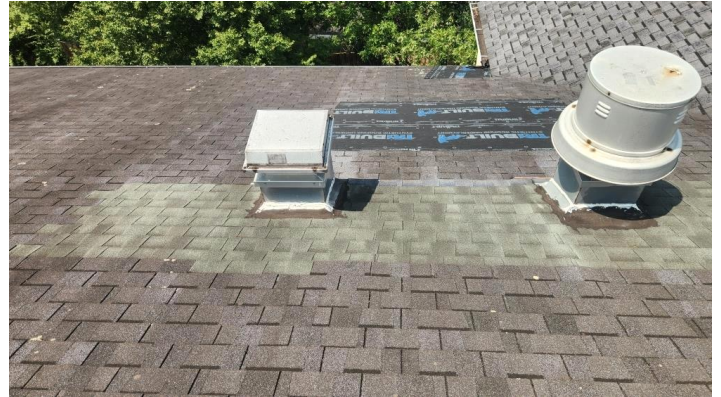
Prior repair by others  
Missing shingles and only synthetic felt underlayment has  
been installed as a temporary repair

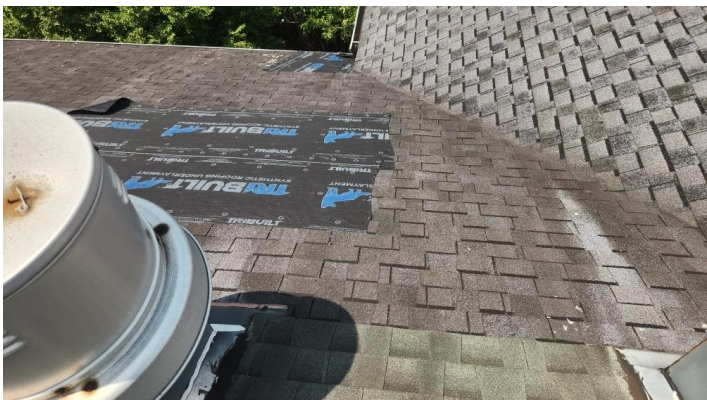
Prior repair by others  
Missing shingles and only synthetic felt underlayment has  
been installed as a temporary repair

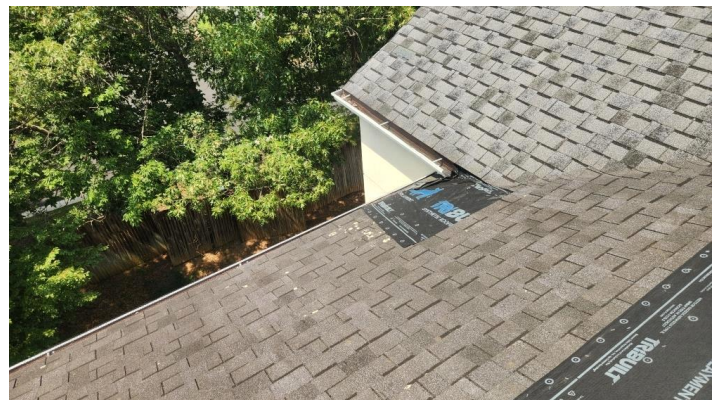
Prior repair by others  
Missing shingles and only synthetic felt underlayment has  
been installed as a temporary repair

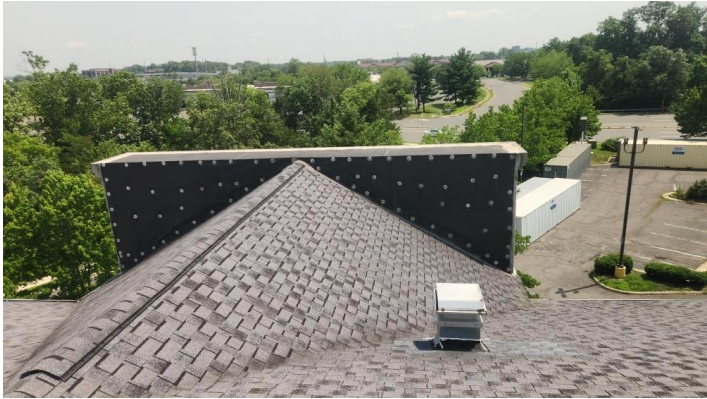
### Improper flashing detail

Step flashing is installed wrong at bottom of wall and improper wall flashing with holes and fasteners everywhere

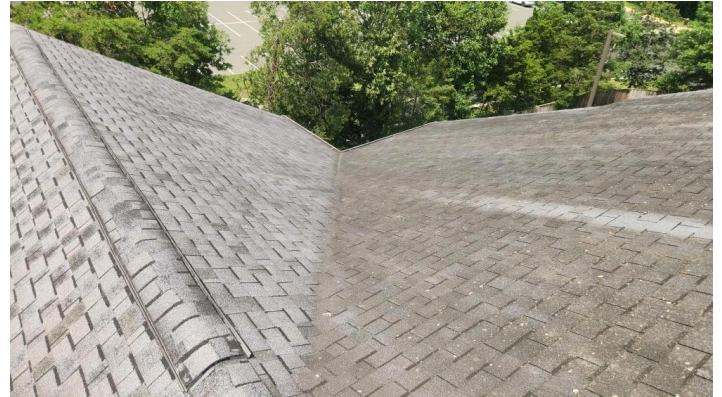
Shingles are in bad shape with alot of granular loss  
The shingle roofs need to be replaced

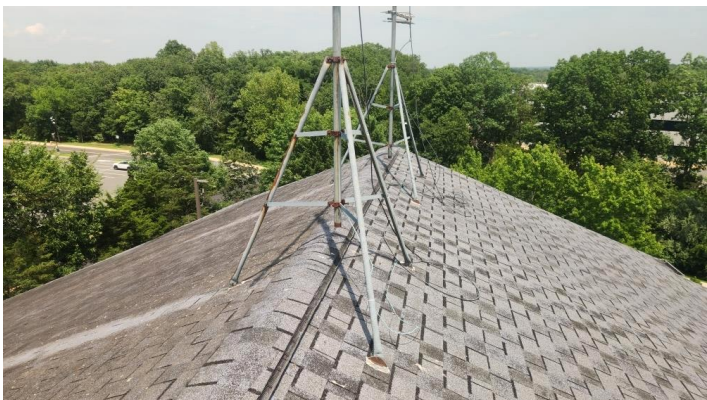
### Sealant Deterioration/Failure

Sealant should be removed and replaced to prevent water entry.

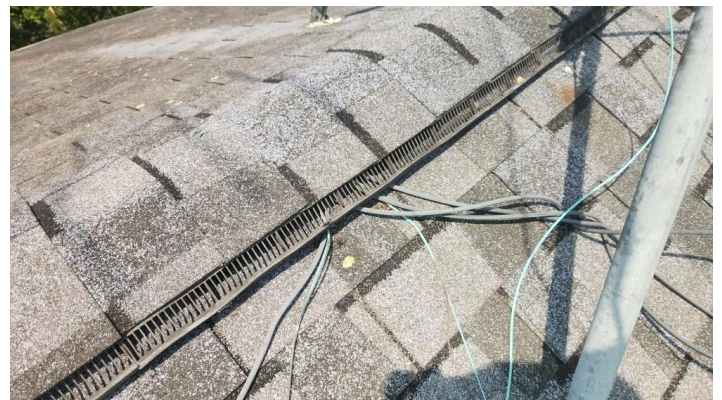
### Improper flashing detail

These lines should go into a proper roof flashing

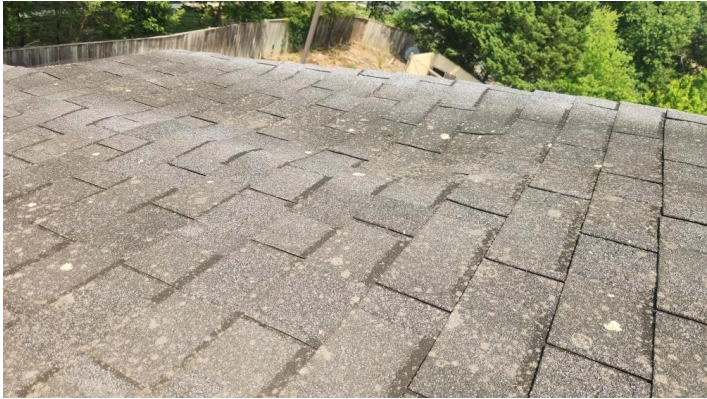
Bowed plywood

Plywood needs to be replaced and new shingles installed

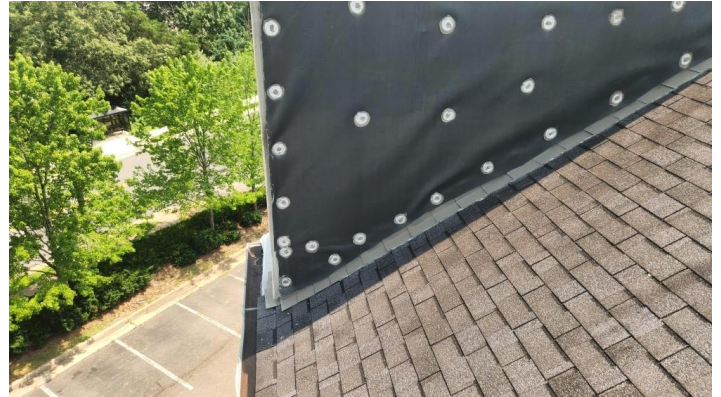
Improper flashing detail

Step flashing is installed wrong at bottom of wall and improper wall flashing with holes and fasteners everywhere

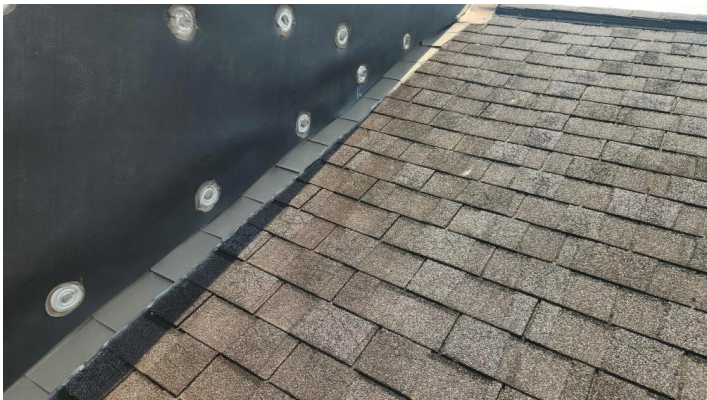
Improper flashing detail

Step flashing is installed wrong at bottom of wall and improper wall flashing with holes and fasteners everywhere

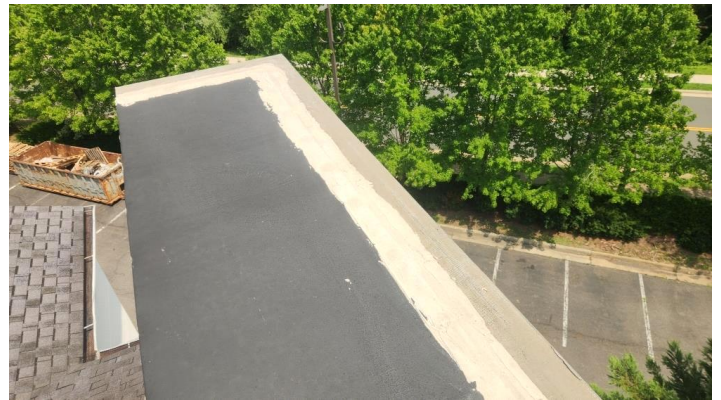
Improper flashing detail

The roof needs to be replaced

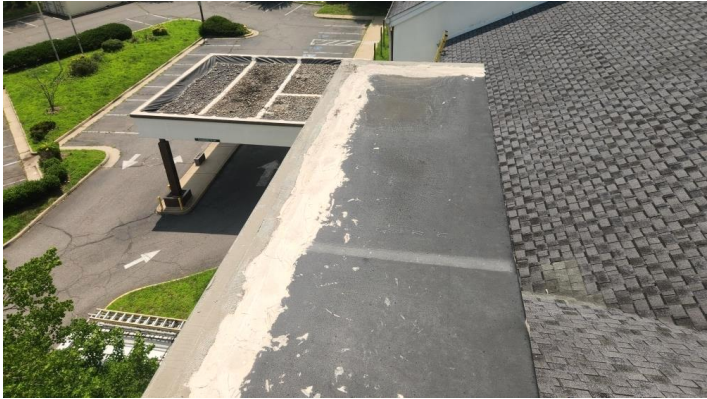
Improper flashing detail  
The roof needs to be replaced

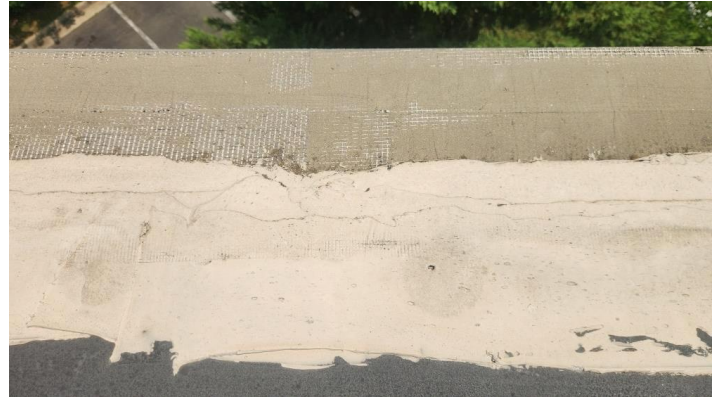
Improper flashing detail  
The roof needs to be replaced

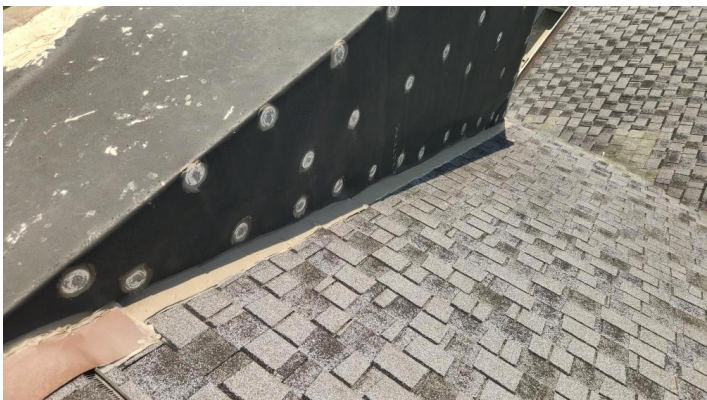
Improper flashing detail  
Step flashing is installed wrong at bottom of wall and  
improper wall flashing with holes and fasteners everywhere
