## General Observation

Report #: 002

**Client:** DCMi Mid-Atlantic Inc.  
**Project:** La Quinta Hotel  
**Location:** 6950 Nova Way, Manassas, VA - 20109

**Report Date:** 07/17/2026  
**Project #:** G2026-123

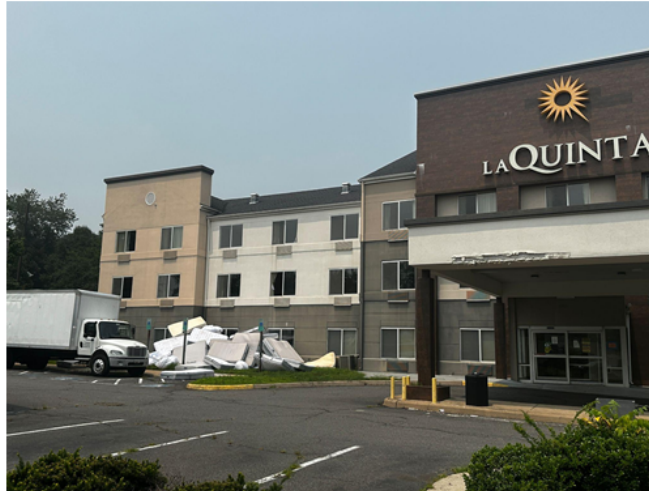
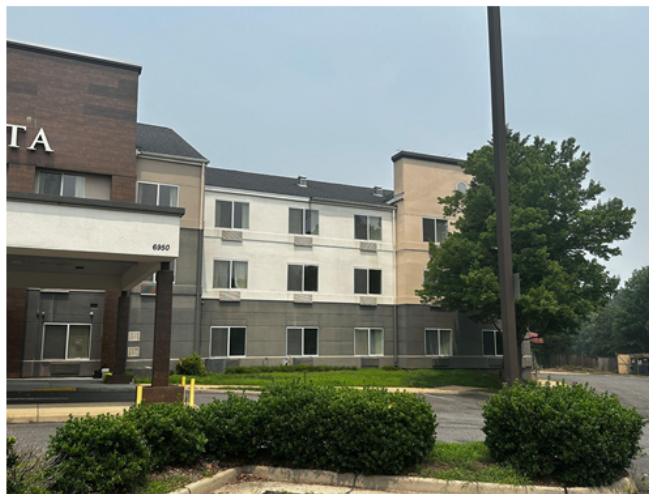
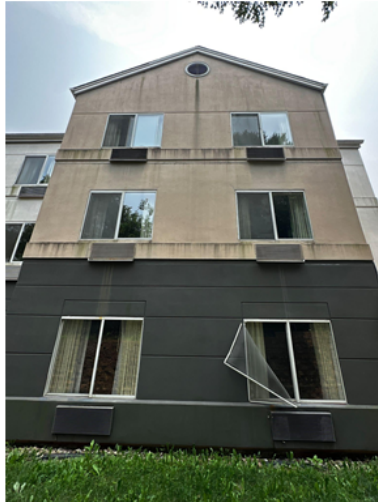
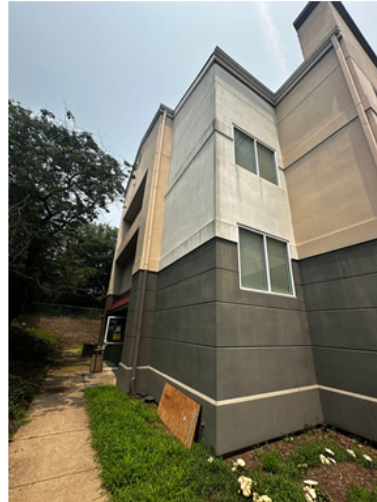
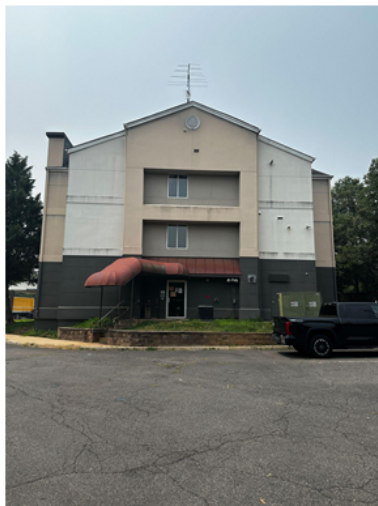
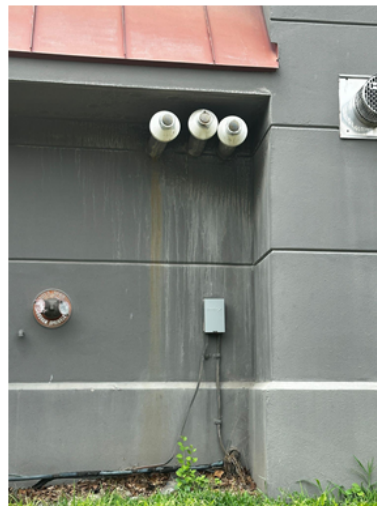
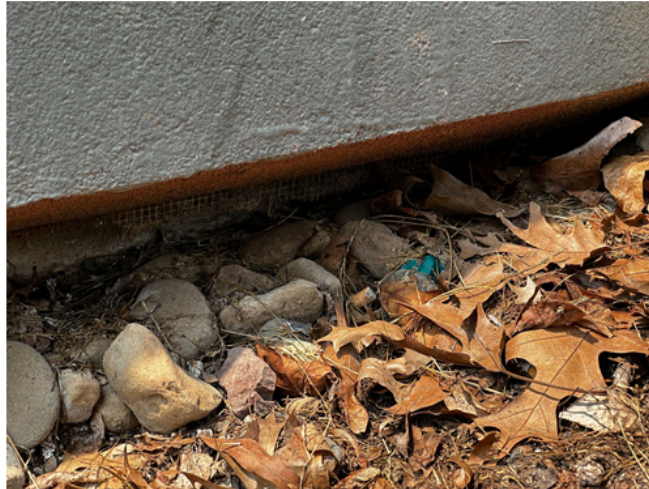
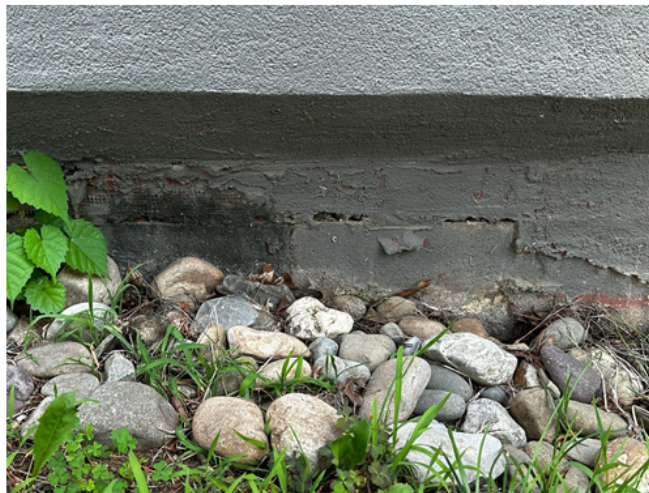
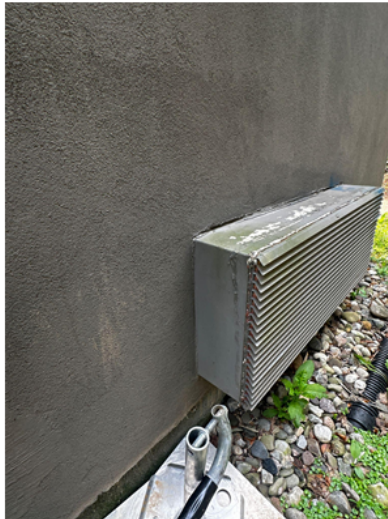
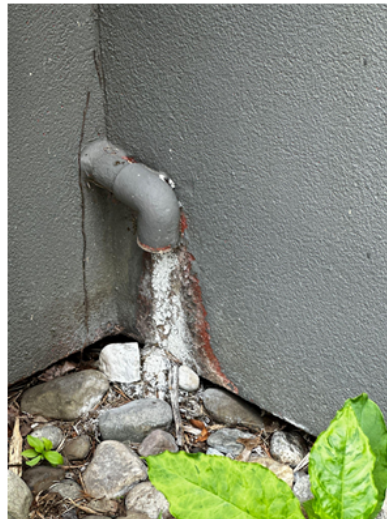
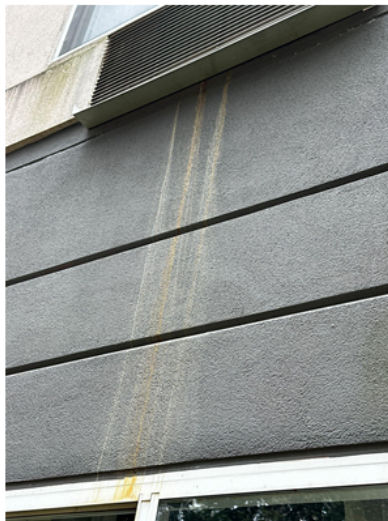
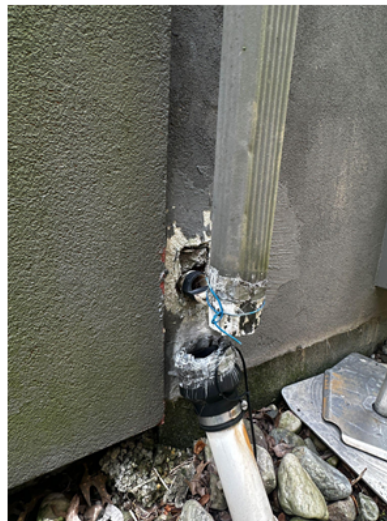
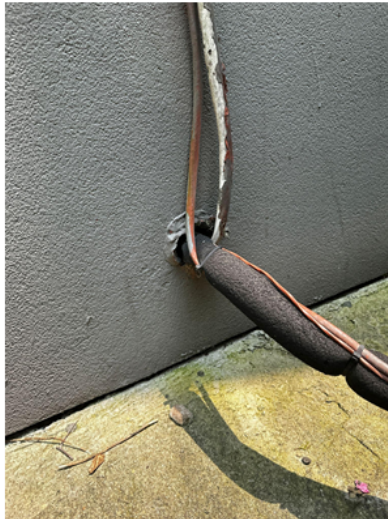
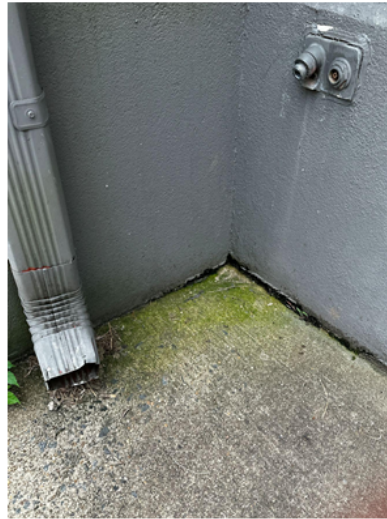
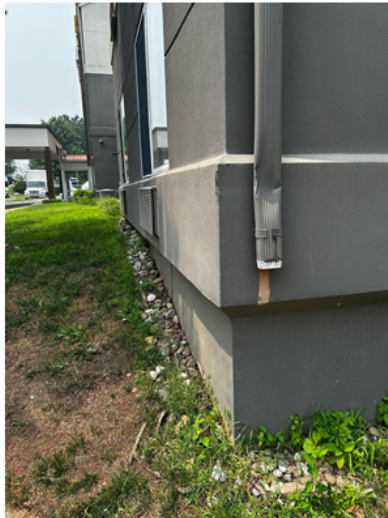
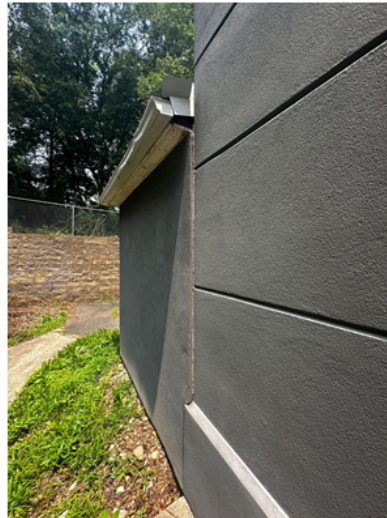
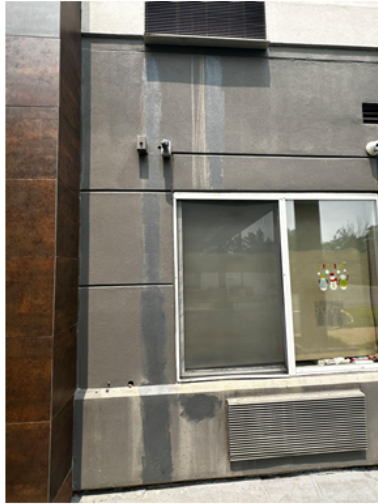
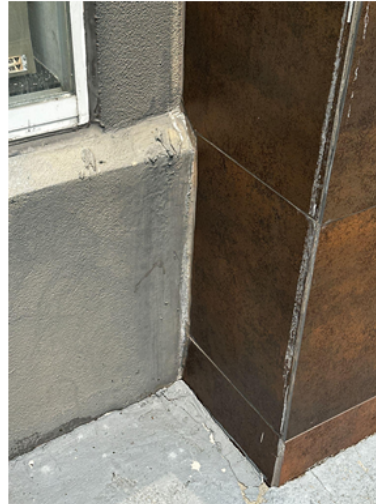
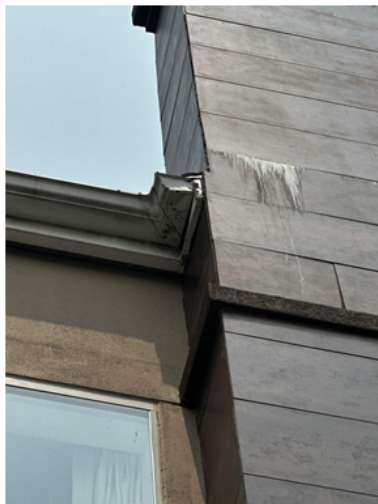
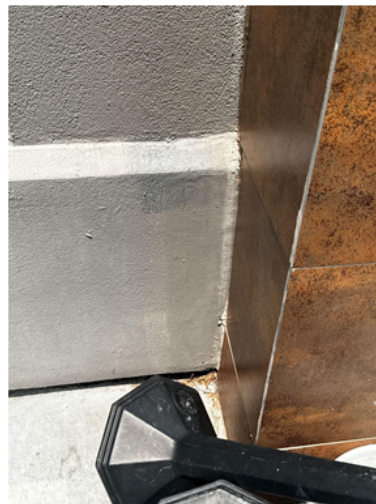
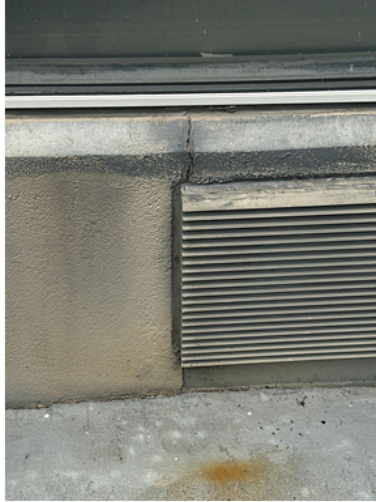
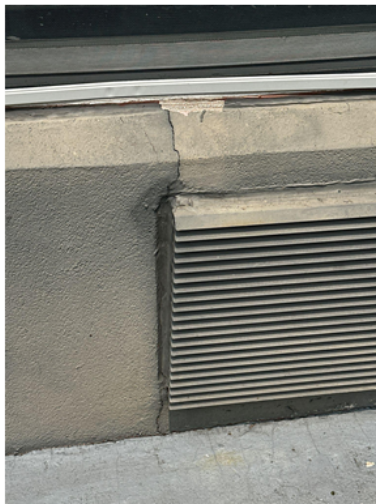
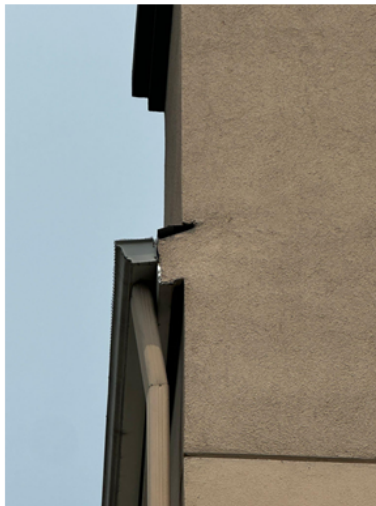
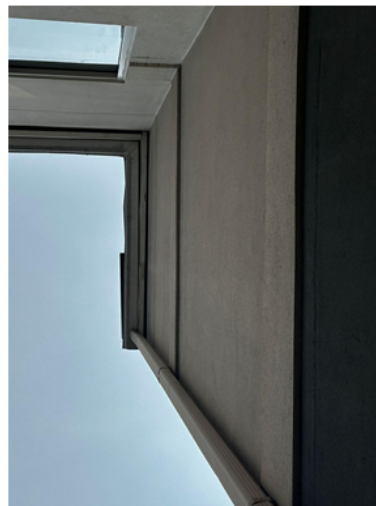
## EXTERIOR EIFS

Across the structure's EIFS, all wall faces were observed to have green and black growth, rust colored trailing beneath the majority of AC drainage tracks, and concentrated moisture damage at the majority of downspouts and gutter terminations at abutted corners. The northern wall face of the structure was observed to have the highest concentration of the issues listed above with the majority of them presenting on the exterior of the 3rd and 2nd stories. However, it was also observed that the grade-level, inward-slanted flange, located at the EIFS grade termination had been incorrectly wrapped over by the reinforcing mesh and then sealed against the foundation slab, thus trapping moisture against the wall and inside of the EIFS. While viewing the exterior, the Global representative also observed that a large majority of roof, gutter, and downspout connections present on the structure had suffered from deformation and no longer worked together as the systems design had likely intended. This is best observed at the abutted corners of the northern wall face where increased green and black growth can be observed to originate directly from the gutter to wall face connection. Photos of the issues listed above, as well as images of other exterior damages are attached below.

**Remarks:** Due to the distribution of deficient factors across the entire structure's EIFS, it is of the opinion of the Global Representative that total replacement of the structure's EIFS be required.

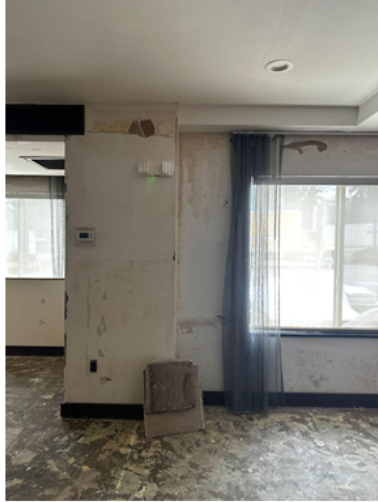
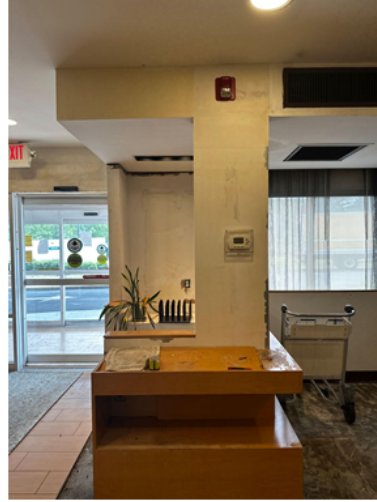
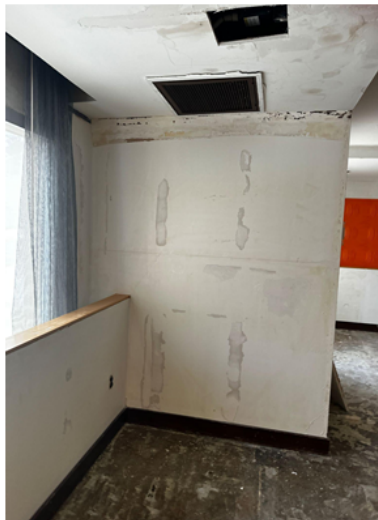
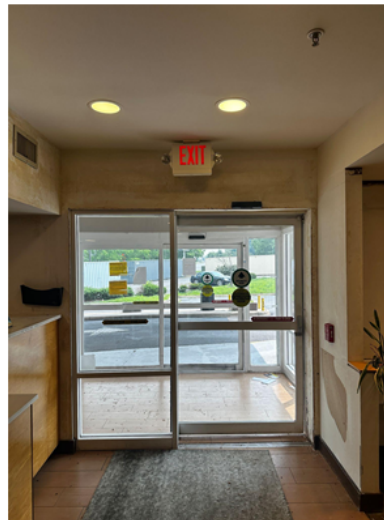
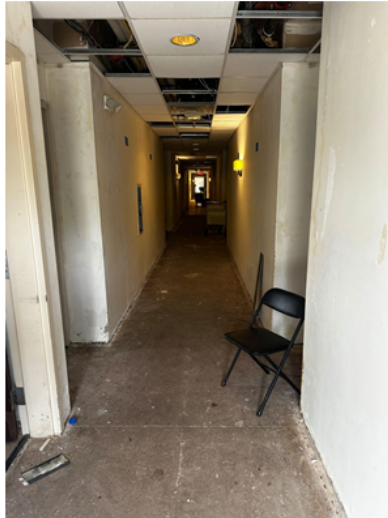
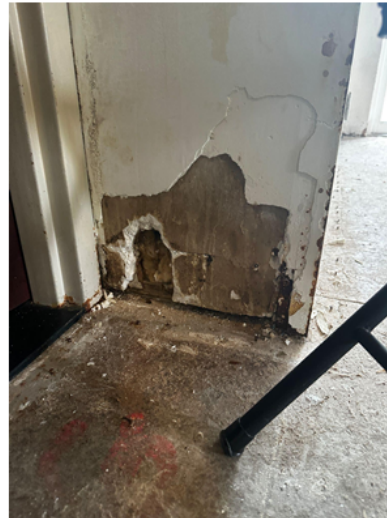
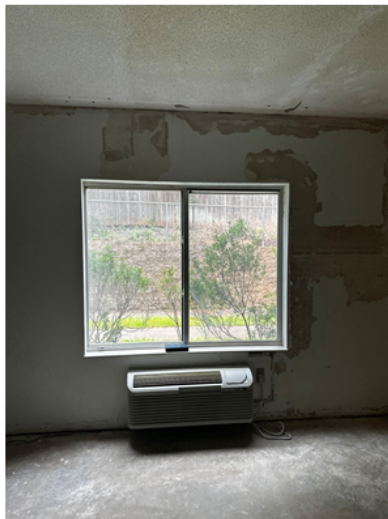
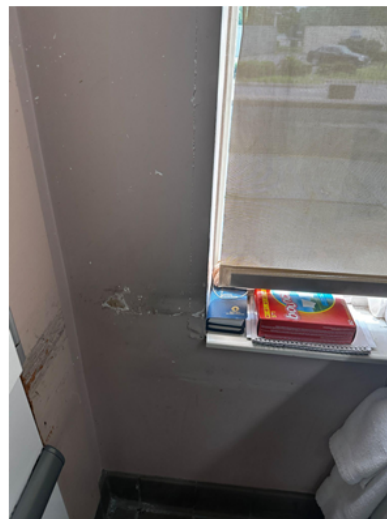
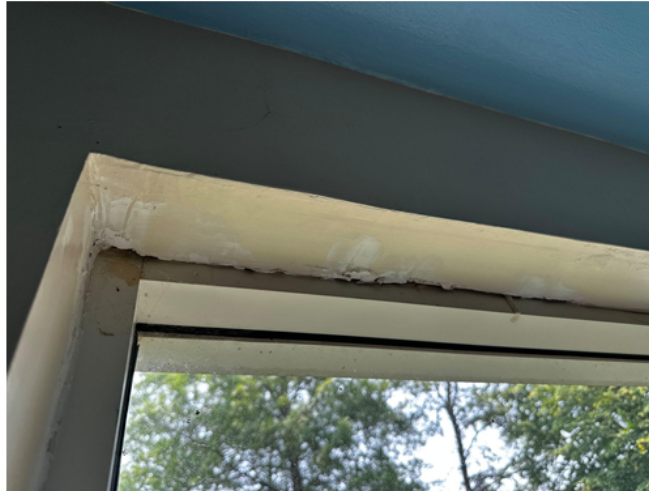
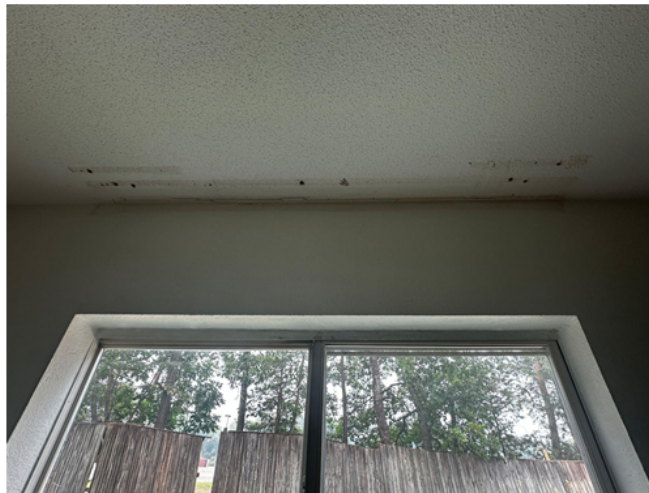
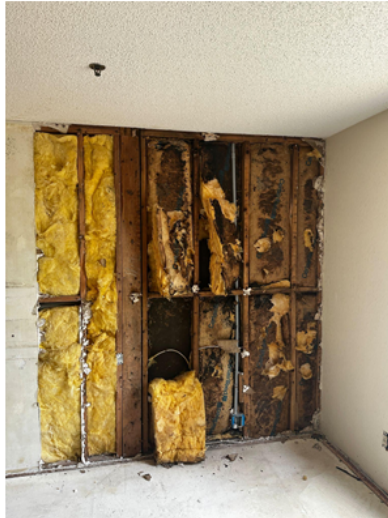
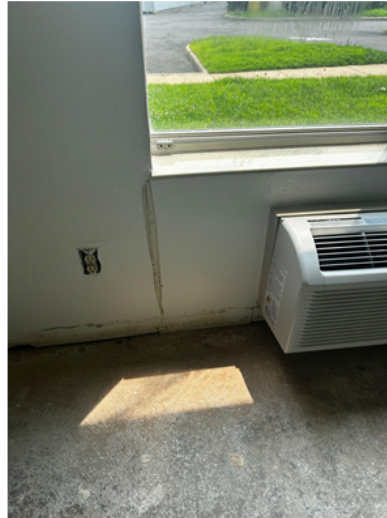
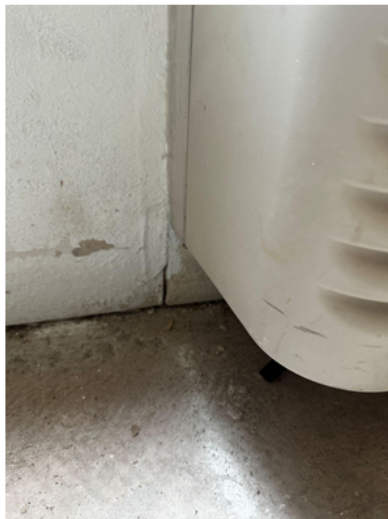
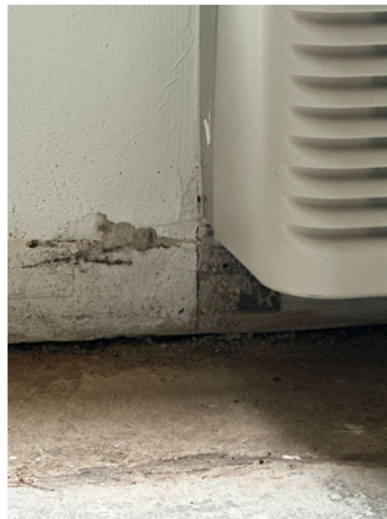
## 1ST STORY INTERIOR

Moving from the exterior of the structure to the interior of the 1st floor, the global representative observed consistent moisture damage across open areas, stairwells, and 1st story units. The main gathering area/entrance way of the structure displayed heavy discoloration of the wall finishes, localized mold/mildew growth, and rust present on air vents and corner beads. 1st story hallways were observed to have peeling paint and finishes alongside visible damage to drywall and insulation within the hallway. Once the Global representative finished walking the entrance way and main hallway, they began walking through the interior units near locations where exterior damage could be observed. Of the 1st story units observed by the Global representative, the majority of the 1st story units had moisture residue and open wall punctures surrounding the AC units and window frames. Units 127, 123, 121, 111, 109, 103, and the pool room were observed to have unique visible issues of note. Unit 127 had mold patches present on the west wall. Unit 123 was observed to have an aggressive musty and earthy odor. Unit 121 was observed to mimic the aggressive odor present in 123 while also having roofing cave-ins present which visibly exposed upper-level insulation, framing, and MEP systems. Ceiling tiles surrounding the caved-in area were observed to also have rusted connector screws, indicating further moisture intrusion between framing items and the insulation cavities present in the ceiling. Units 111 and 109 had a less aggressive musty and earthy odor. Lastly, it was observed in the east most window of the pool room that the sealed connection between the window frame and wall had largely degraded and exposed interior systems to moisture from the exterior and interior. The Global representative was unable to assess each room individually due to activity on site at the time of the assessment, therefore the issues listed above should not be considered to be the only issues present across the 1st story of the structure.

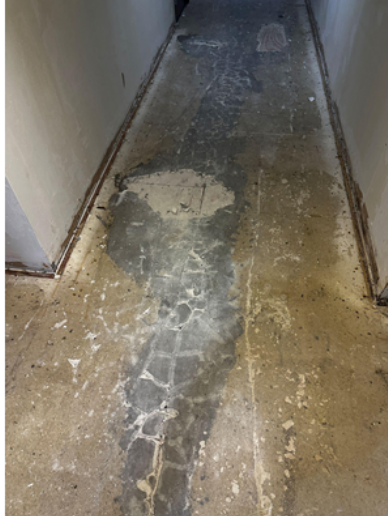
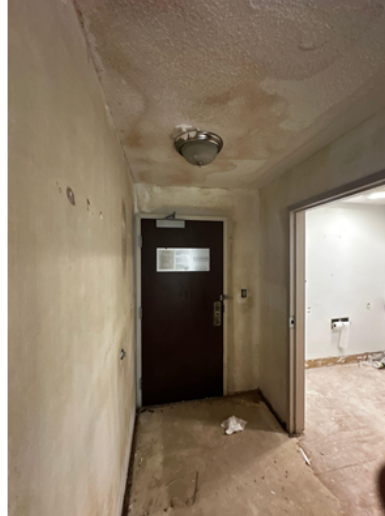
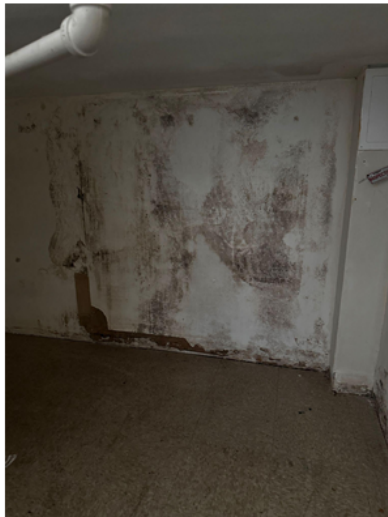
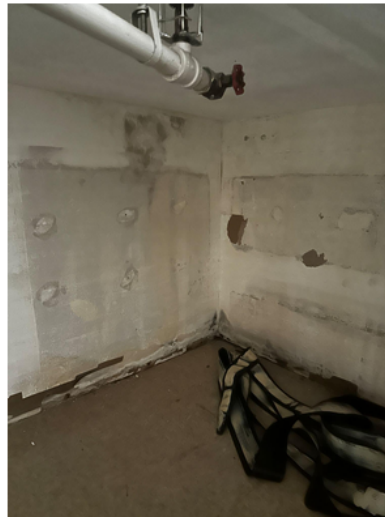
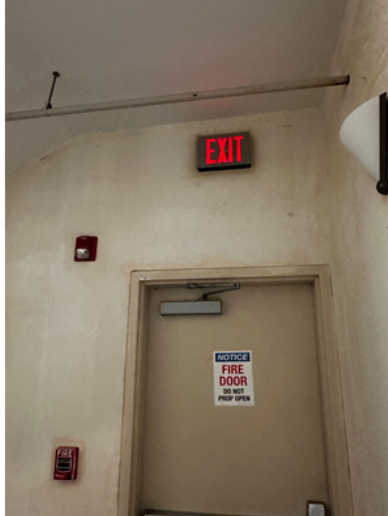
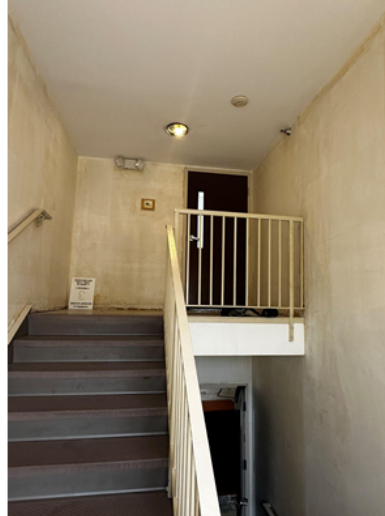
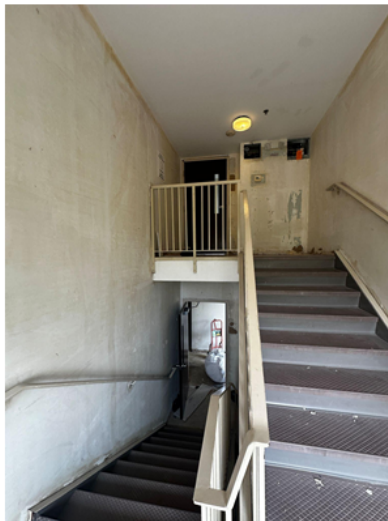
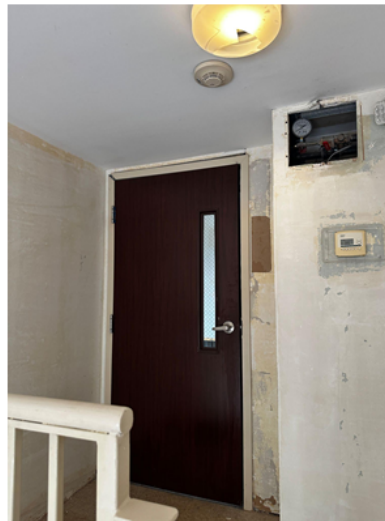
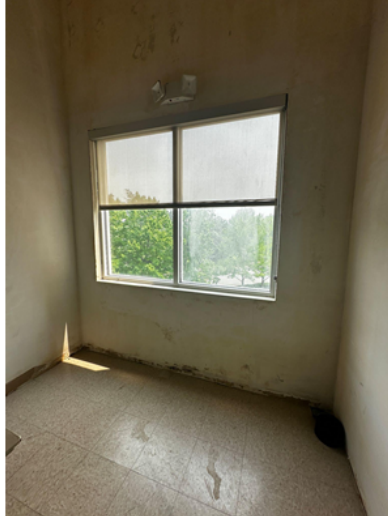
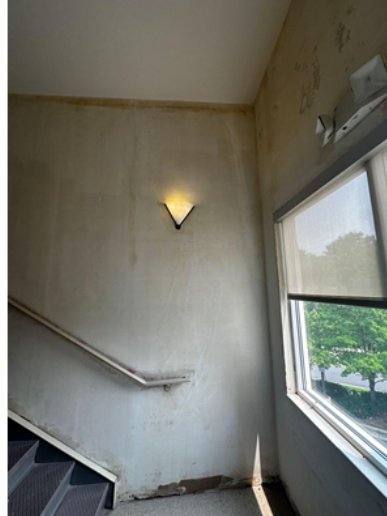
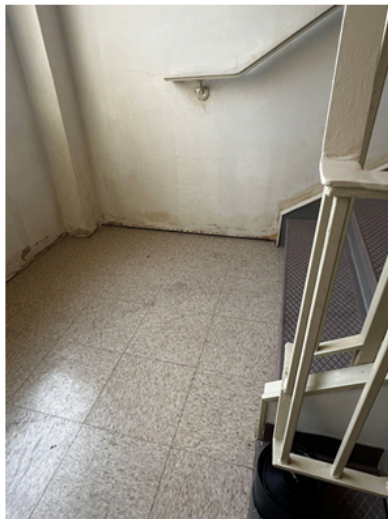
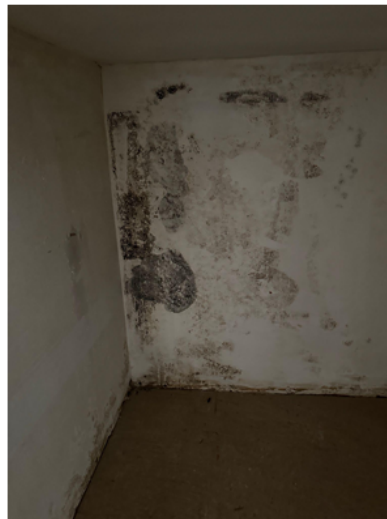
# STAIRWELL INTERIOR

Moving from the 1st story of the structure to the 2nd story, the Global representative noted a musty and earthy odor in both of the structure's stairwells. Upon further observation, both stairwells had black growth beneath their first landings which was present on the southern wall face. The stairwells also displayed similar discoloration in the walls as seen in the 1st story hallways, entrance way, and across multiple units. It was also observed in the stairwell that the precise drywall fitting to the form of the stair structure was no longer squared and showed heavier discoloration, finish peeling, and signs of rust when compared to other areas inside of the stairwell. Moving towards the upper stairwell, the Global representative observed further discoloration and peeling within the area. It was observed that the framing of the door leading from the eastern stairwell to the 3rd story had separated from the wall's substructure and that a vertical crack on the eastern corner of the frame had formed. This crack ran from the corner of the frame up to the ceiling and connection joint.

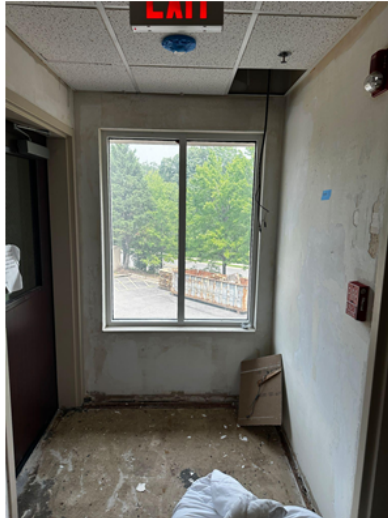
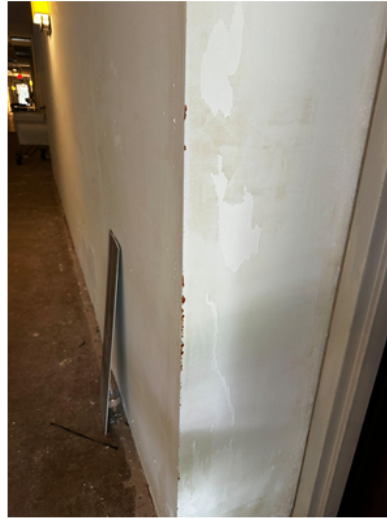
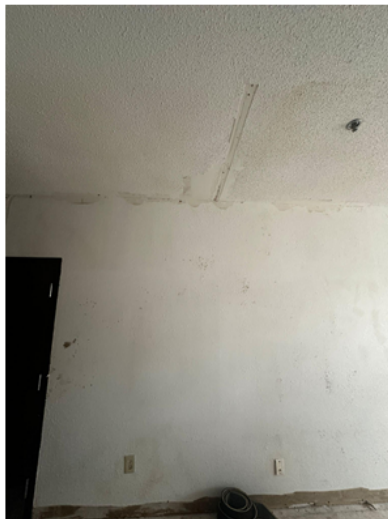
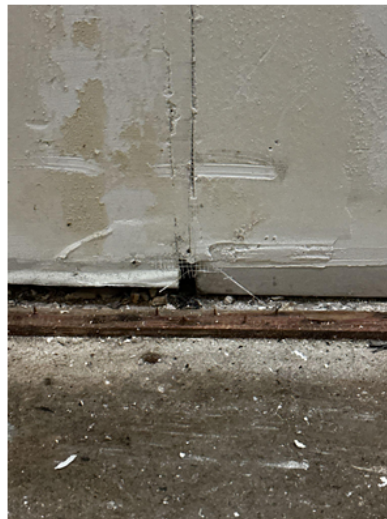
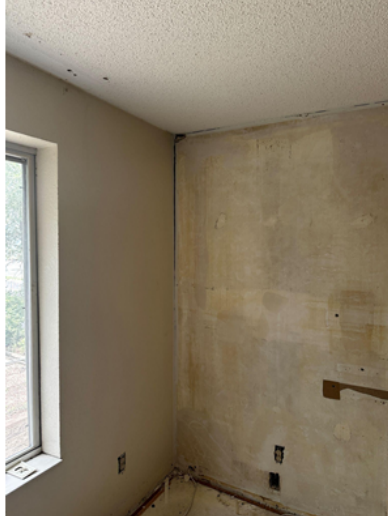
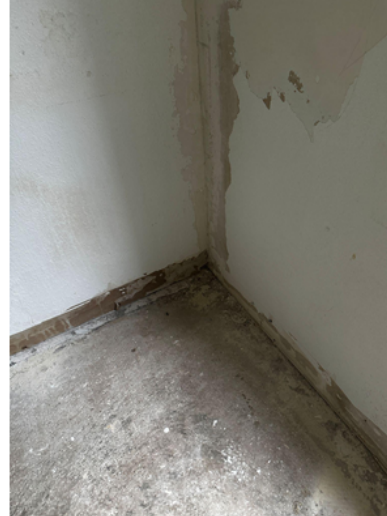
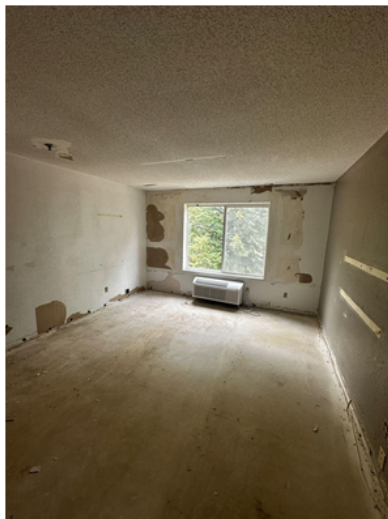
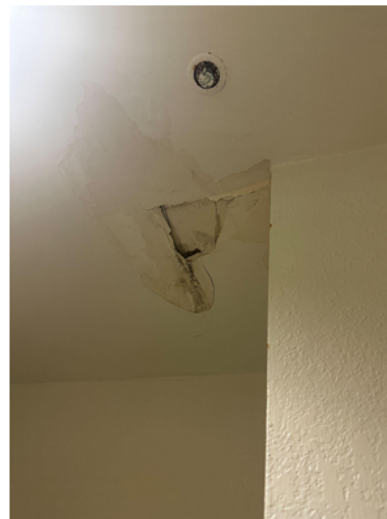
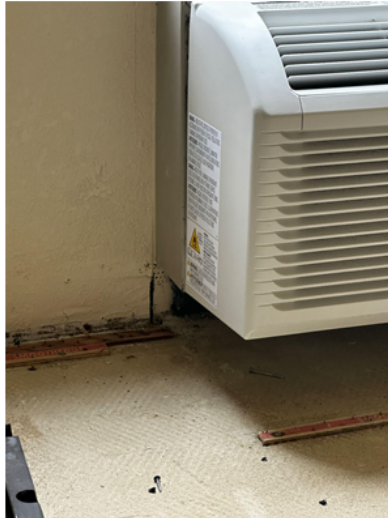
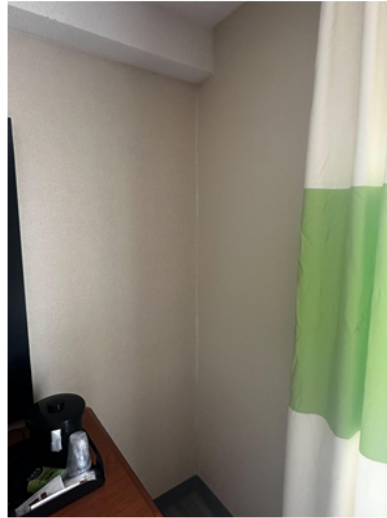
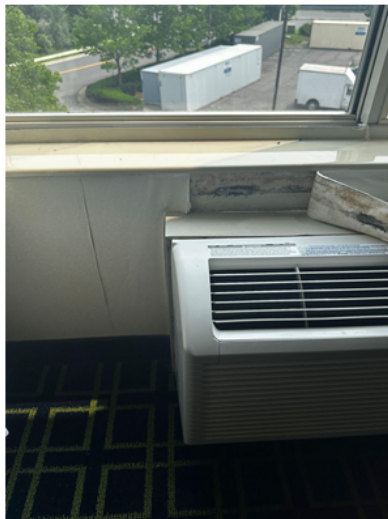
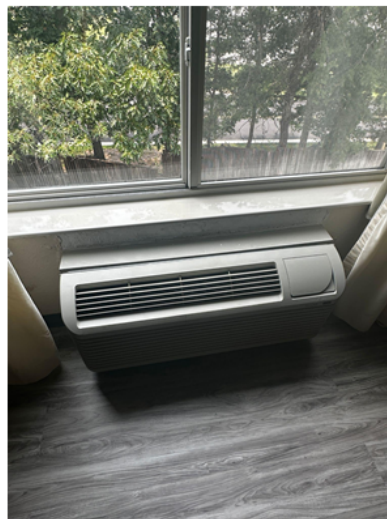
## 2ND STORY INTERIOR

Moving from the stairwell to the second story, many of the issues for the first story were mimicked across the main hallway, exterior windows, and amongst the units. Specific units of note were 223, 221, 219, and 211. Unit 223 and 221 suffered from a ceiling cave with the same observed deficiencies and scent as unit 123. Unit 219 was observed to have a musty and earthy odor which can be verbally described as having the same odor as a "rotting pumpkin." Lastly, unit 211 had an exposed insulation cavity on the western wall face that was observed to be wet, rotted, and covered in black growth. Similarly to the 1st story, the Global representative was unable to assess each room individually due to activity on site at the time of the assessment, therefore the issues listed above should not be considered to be the only issues present across the 2nd story of the structure.

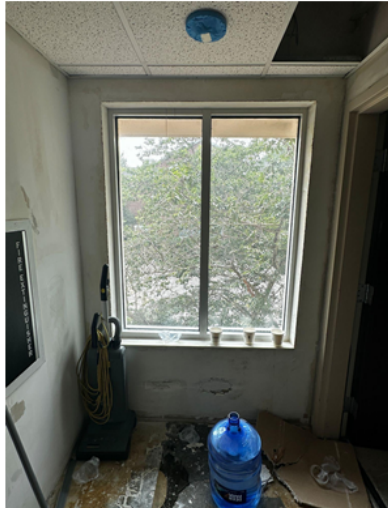
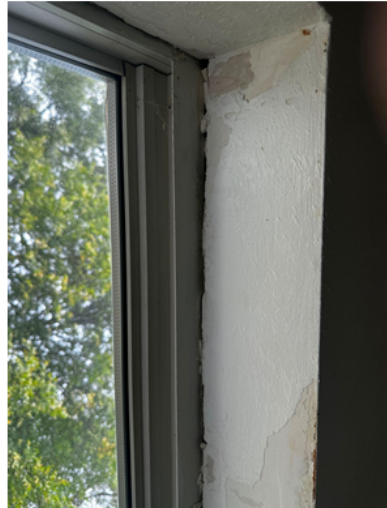
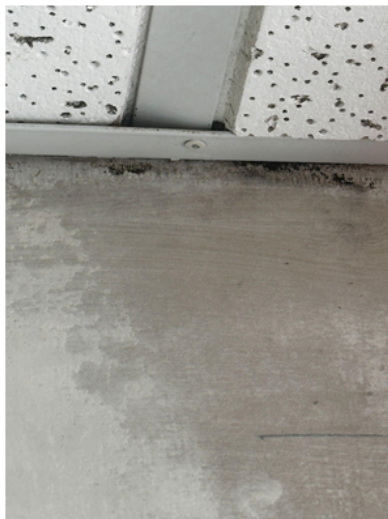
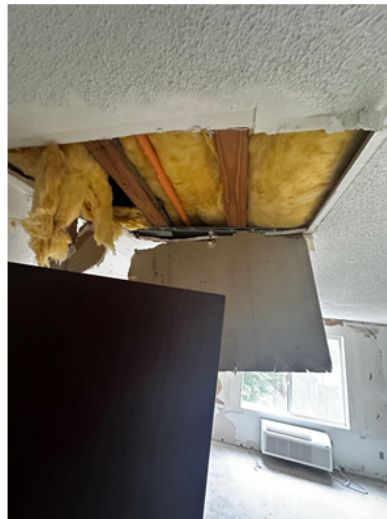
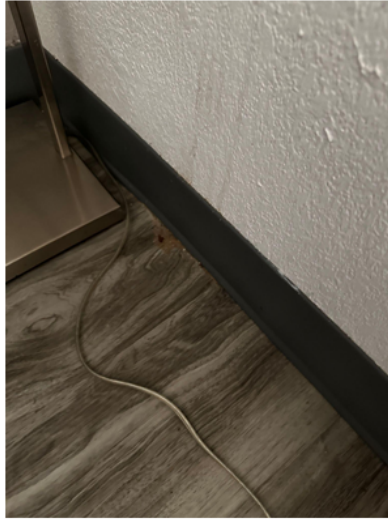
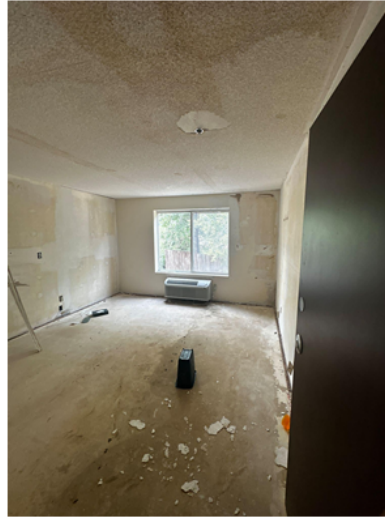
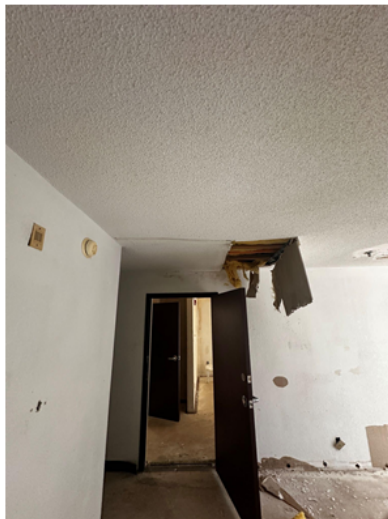
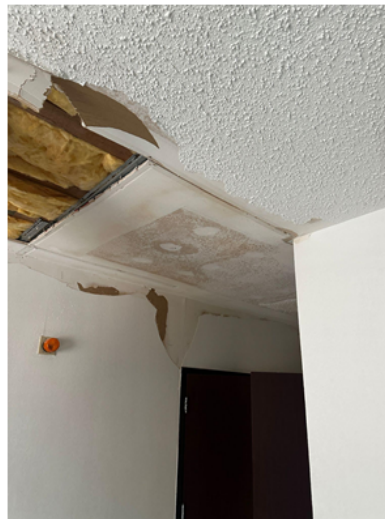
## 3RD STORY INTERIOR

Upon entering the third floor from the eastern stairwell, similar observations from the 1st and 2nd story were noted across the hallways, sub-ceiling, and exterior windows. The 3rd story was observed to have higher concentrations of wall penetrations near the AC units, window frame separations from the walls, moisture residue, and the aggressive musty and earthy odor across the 3rd story. Two notable units were 327 and 324. Unit 327 was observed to have an exposed wall in similar condition to that of unit 127. Unit 324 was observed to have visible rot present around the AC and wall framing with large cracks around the window frame. Similarly to the 1st and 2nd stories, the Global representative was unable to assess each room individually due to activity on site at the time of the assessment, therefore the issues listed above should not be considered to be the only issues present across the 3rd story of the structure.
