## HRS Structural Consultants LLC

**August 1, 2026**

**Subject:** Structural Visual Assessment of La Quinta Inn Building Located in Manassas, Virginia

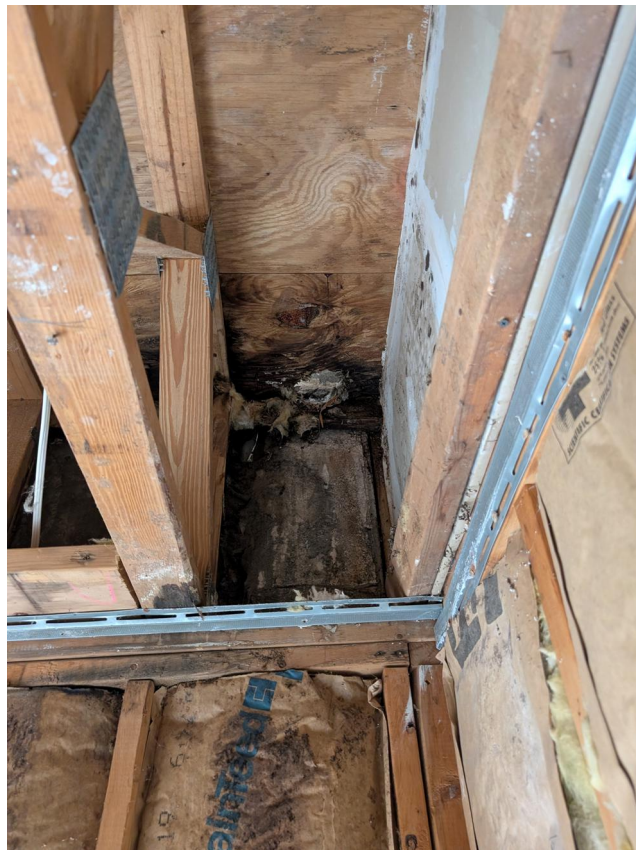
Observed damage included deterioration of various structural and nonstructural wood components, including wall sheathing, wood studs, sill plates, top plates, headers, and localized framing members affected by prolonged moisture exposure.

**Water damage in the structure in room 225**

The observed water-damaged structural wood members, including deteriorated wall sheathing, studs, blocking, sill plates, top plates, headers, and any other framing components exhibiting deterioration, should be replaced where the damage has compromised the structural integrity or serviceability of the member.

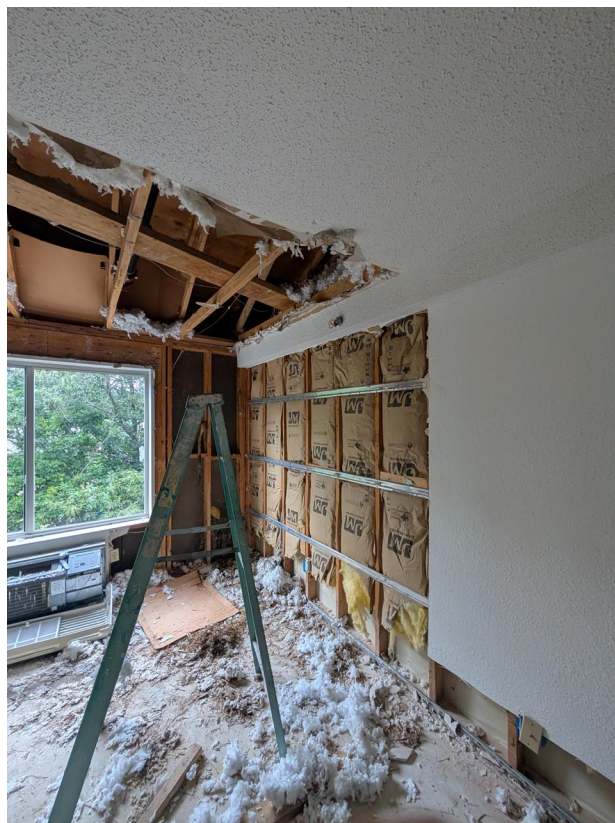
Exposed structure in room 325 and damaged areas

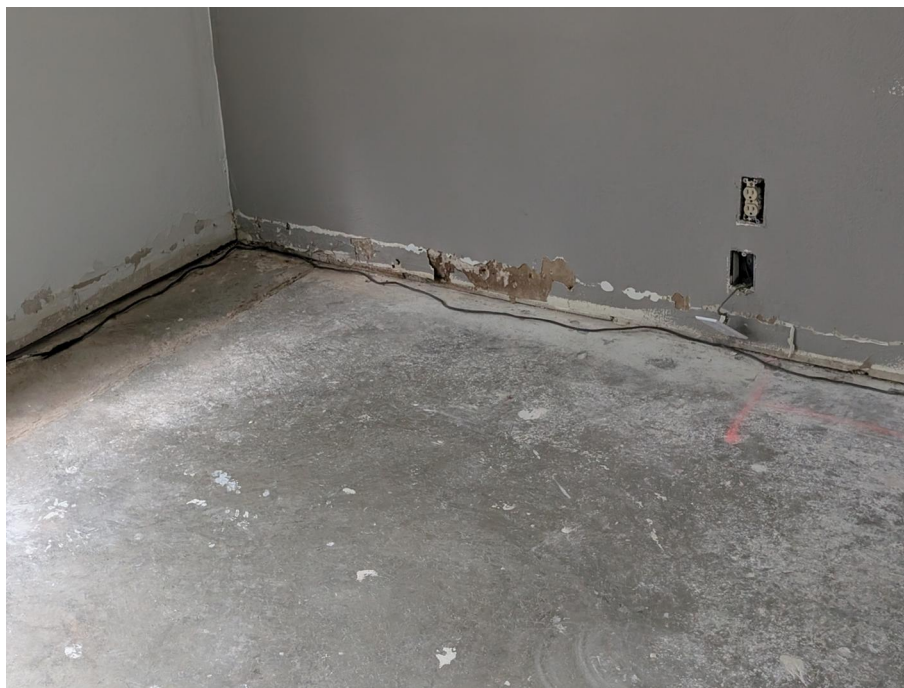
In addition to the water-related damage, several cracks were observed in portions of the slab-on-grade at the first floor. Based solely on the visual observations, these cracks appear consistent with long-term differential settlement that has likely developed over the service life of the building. At the time of our inspection, the observed cracking did not indicate evidence of an immediate structural safety concern; however, continued monitoring and further evaluation are recommended to determine the extent and cause of the settlement.

Gap between the drywall and slab due to settlement

The observed slab cracking and indications of long-term settlement should be further evaluated to determine the underlying cause and the extent of foundation movement. Based on the results of that evaluation, appropriate remedial measures should be developed. Potential repair methods may include foundation stabilization, such as underpinning or micro piles where warranted, together with repair of affected slab cracks.

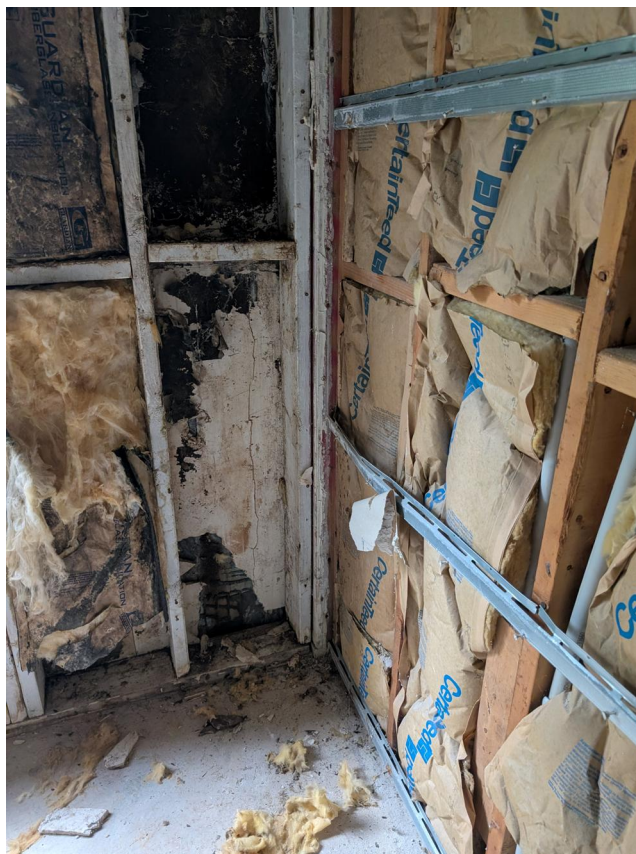
Water damage to the structure in room 125

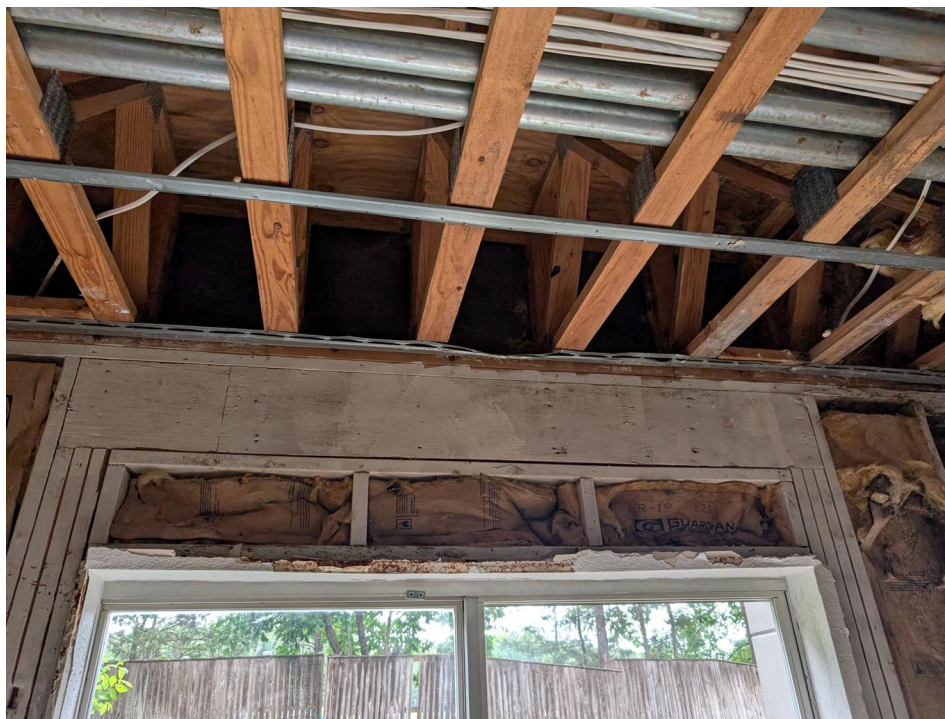
Exposed structure in room 125 and damaged areas

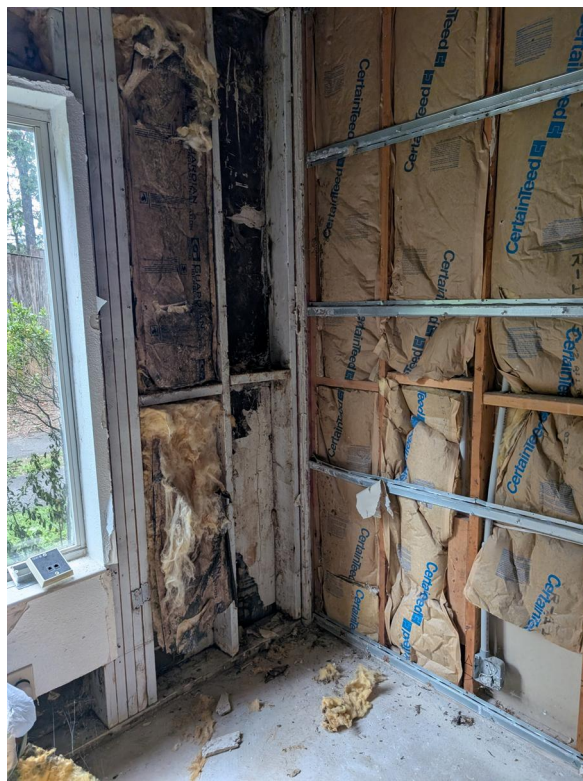
Exposed structure in room 125 and damaged areas

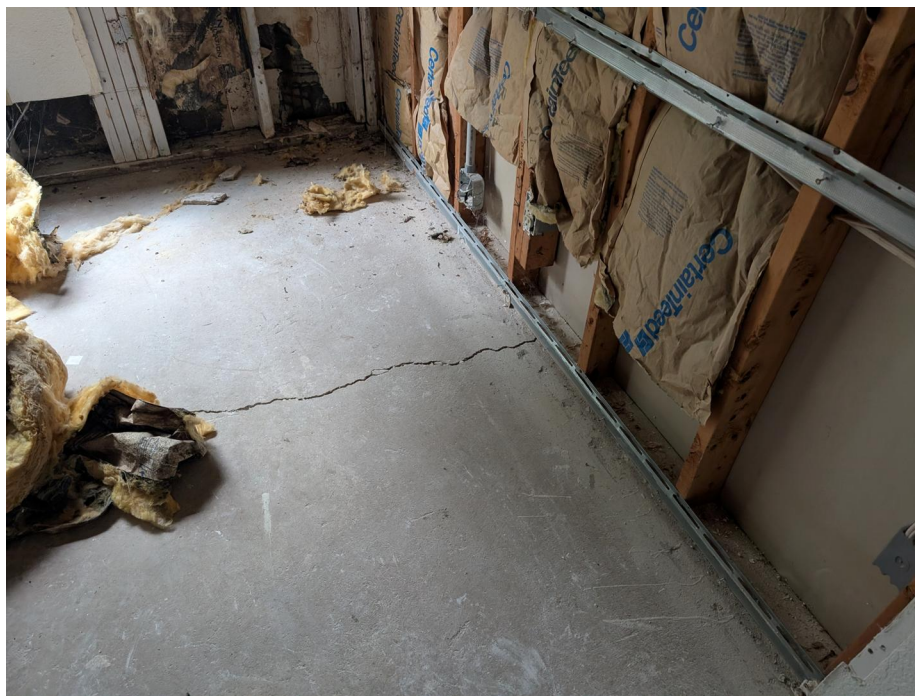
Crack in the slab of room 125 due to settlement

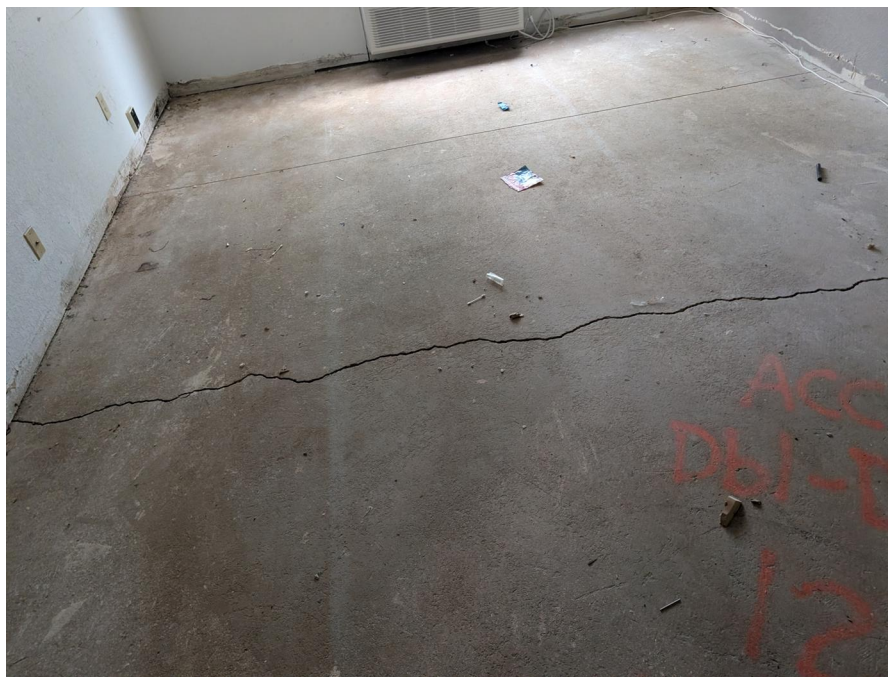
Crack in the slab on grade in the first floor due to settlement

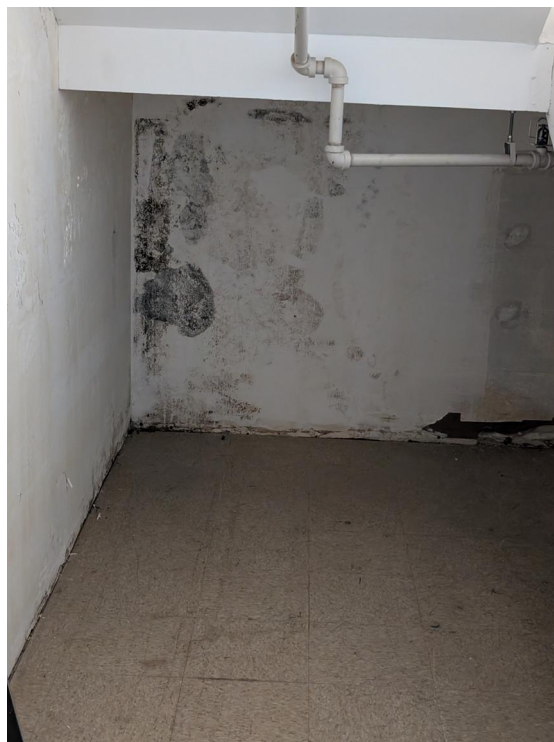
Water staining was also observed in additional areas of the building where structural framing remained concealed behind finished surfaces. Since these areas were not exposed during the inspection, the condition of the structural members behind the finishes could not be verified.

Water damaged area in the first level which is not exposed

Because water staining was observed in additional concealed areas, we recommend exposing all locations suspected of having experienced water intrusion so that the full extent of structural damage can be evaluated. Any damaged structural framing identified during this process should be repaired or replaced as necessary.
