WATER-HEATER PLUMBING DEFICIENCIES REPORT

Spark Hotel | 6950 Nova Way, Manassas, VA

Company: Remington Construction LLC      Report date: July 20, 2026

Report scope: Existing water-heater deficiencies and mandatory corrective work

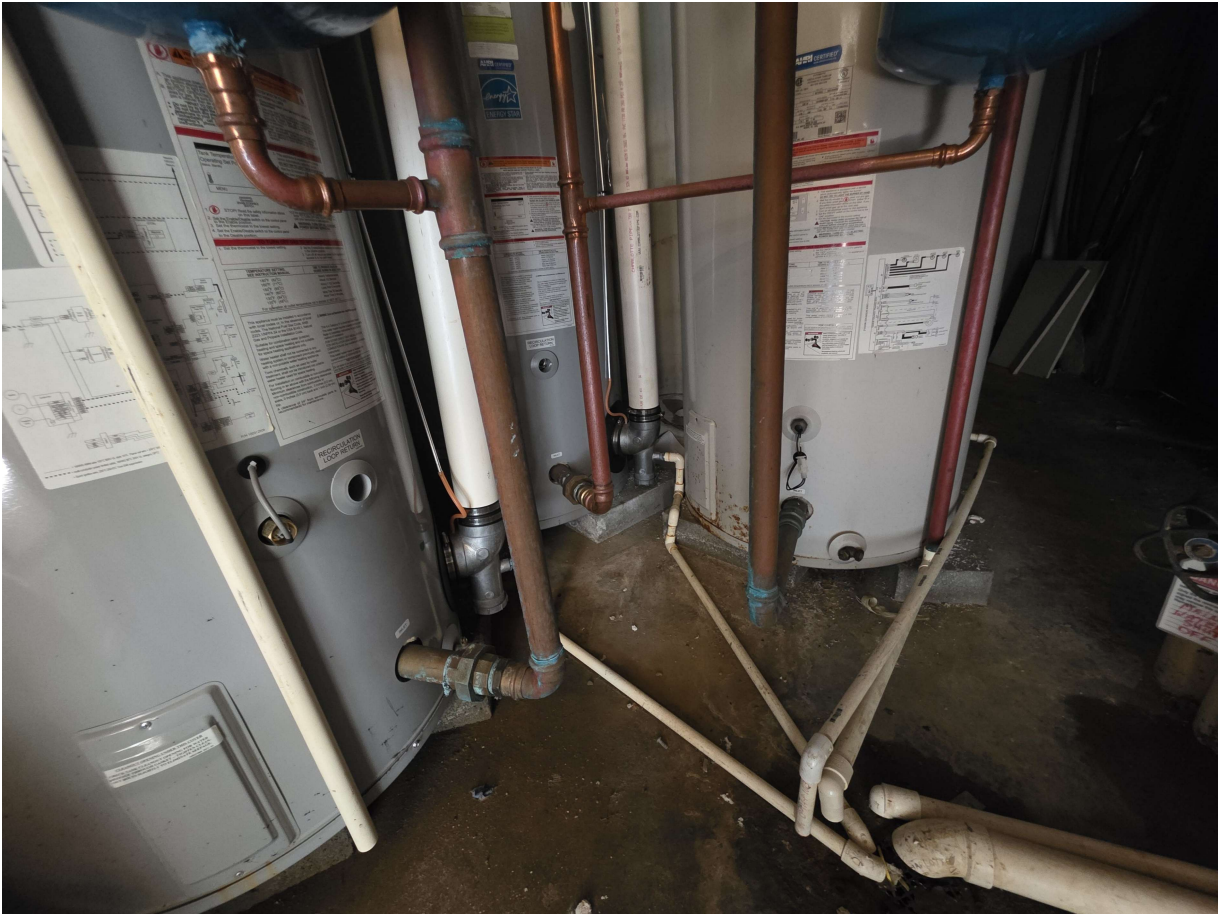
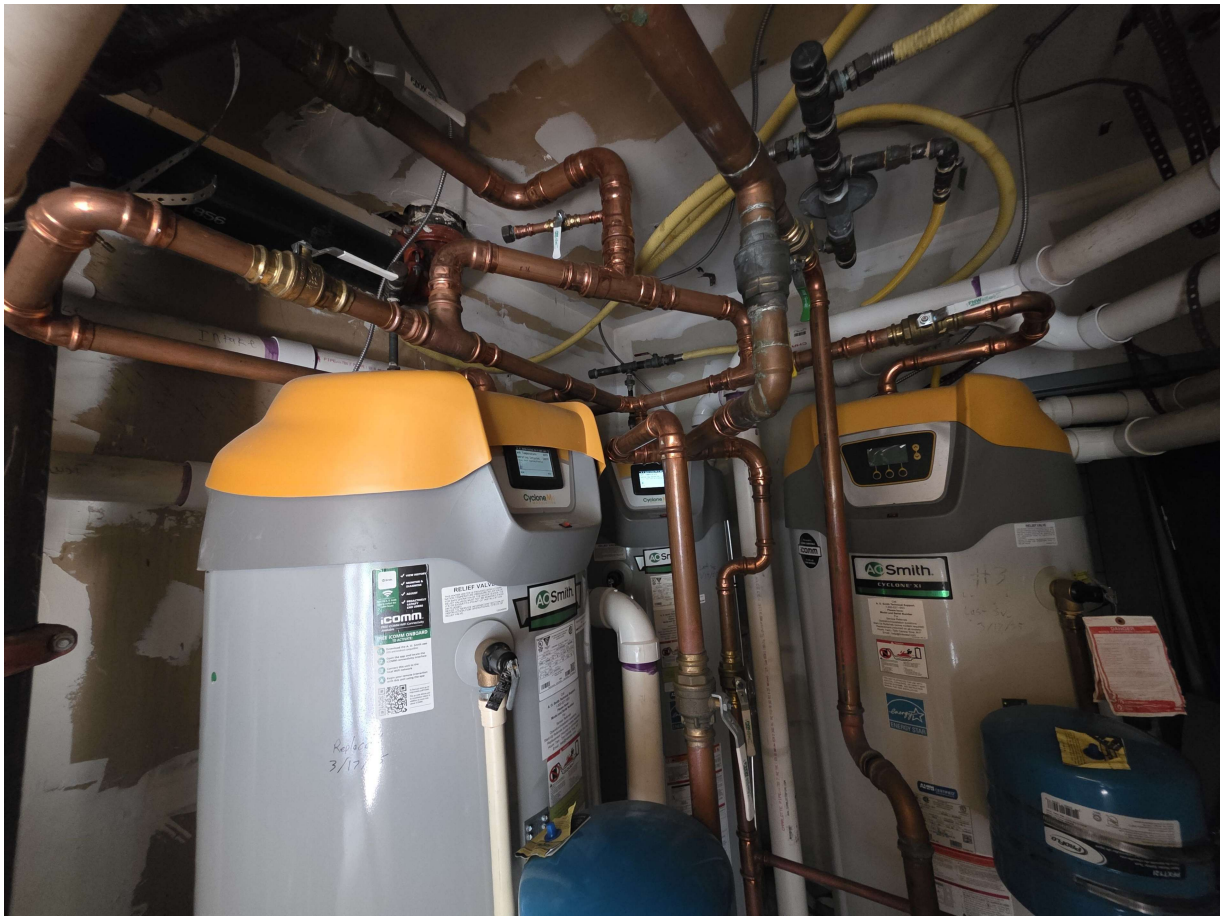
## Task: Check pipes

| No. | Deficiency / Required Work | Field Condition / Scope | Virginia Code Assessment | Required Corrective Action / Verification | Code Reference | Deficiency Status |
|---|---|---|---|---|---|---|
| 1 | Missing grounding | Pipes missing ground protection | installation does not comply requirements for water piping. | Install proper grounding for the copper piping | 2021 VPC | MISSING / NONCOMPLIANT |
| 2 | Missing insulation on water-heater piping | Required insulation is missing from the water-heater inlet, outlet, hot-water and associated service-water piping. | The uninsulated piping is treated as outside all listed exceptions. The installation therefore does not comply with VPC Section 607.5 and VECC Section C404.4, including the applicable insulation thickness requirements. | Install continuous code-compliant insulation of the correct material and thickness. Seal joints, fittings and terminations; coordinate insulation with bonding clamps, valves, unions and pipe supports; verify the approved energy documents. | 2021 VPC 607.5; 2021 VECC C404.4 and Table C403.12.3 | MISSING / NONCOMPLIANT |

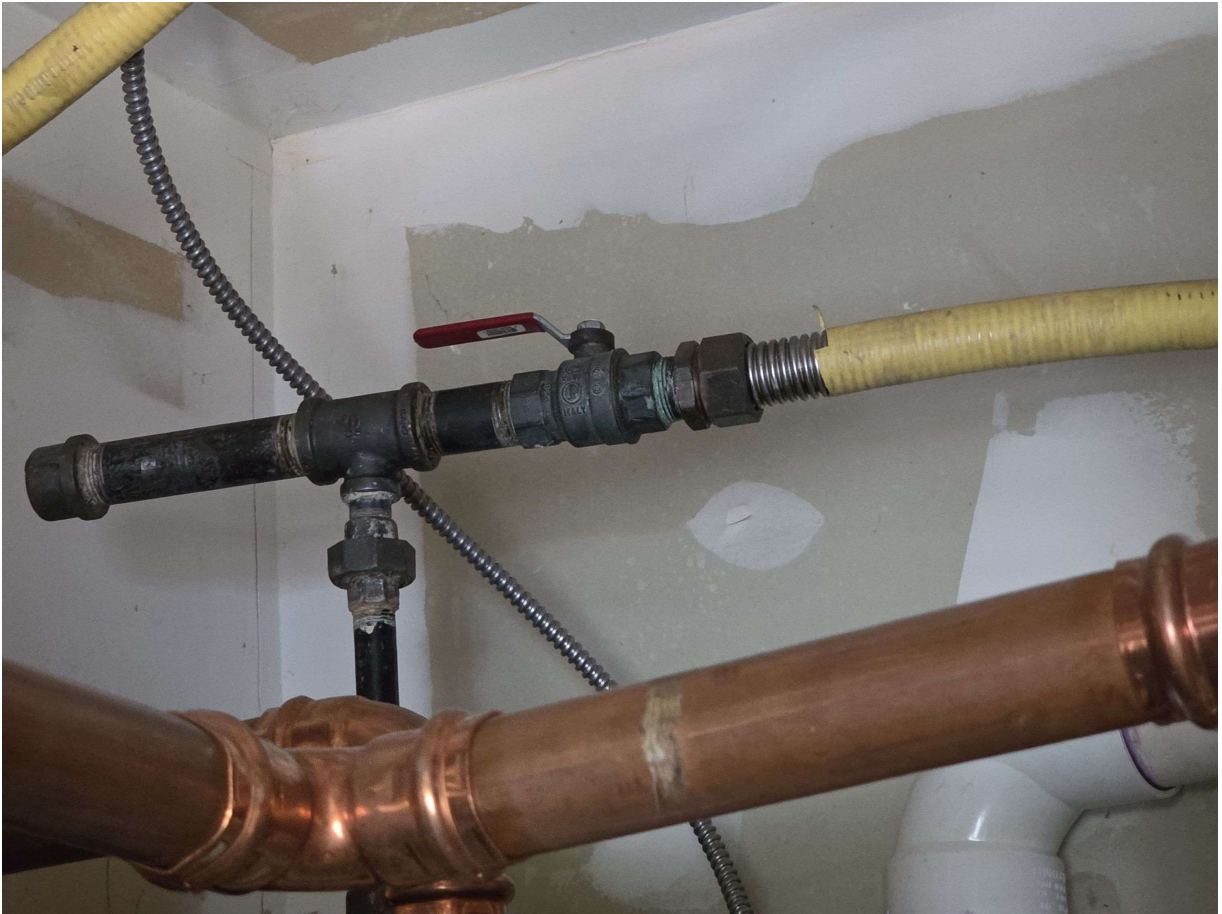
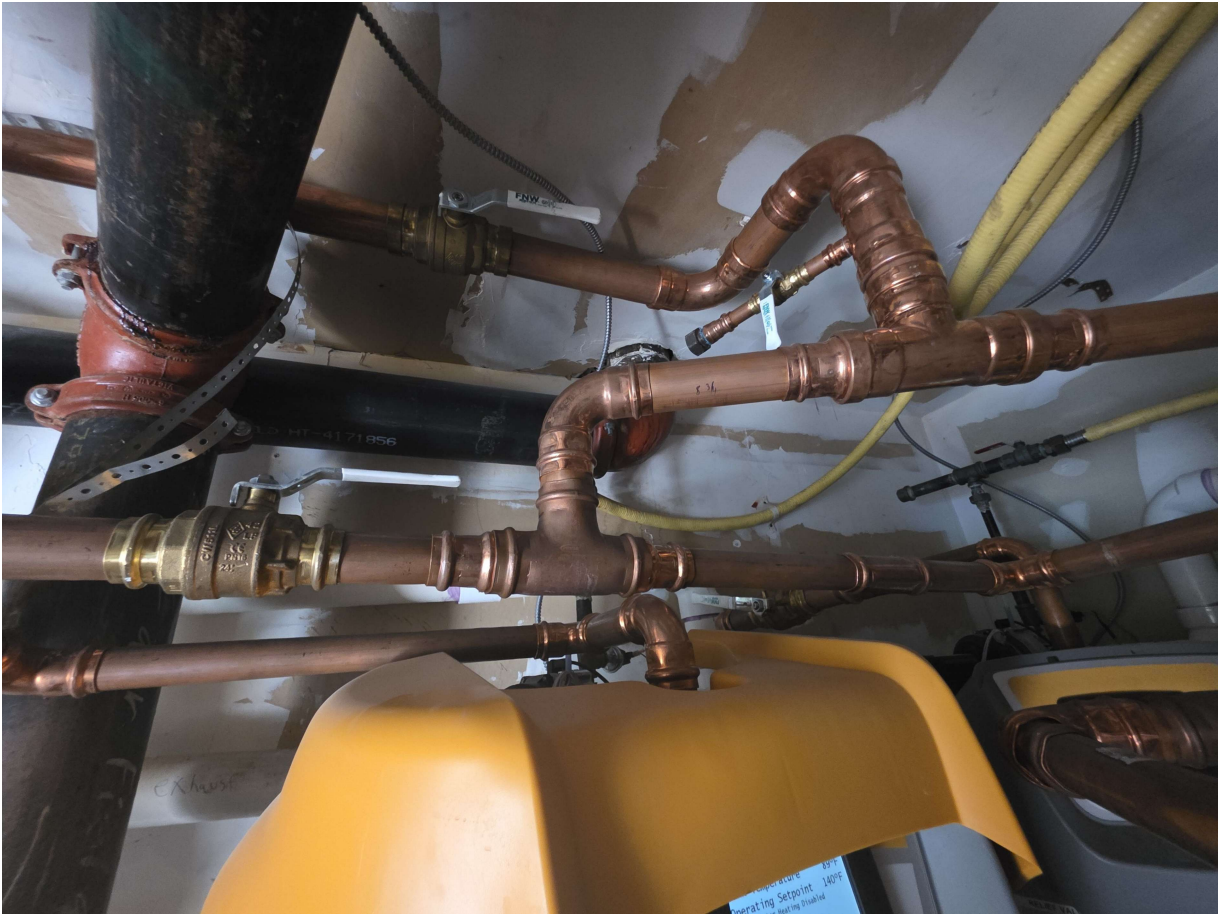
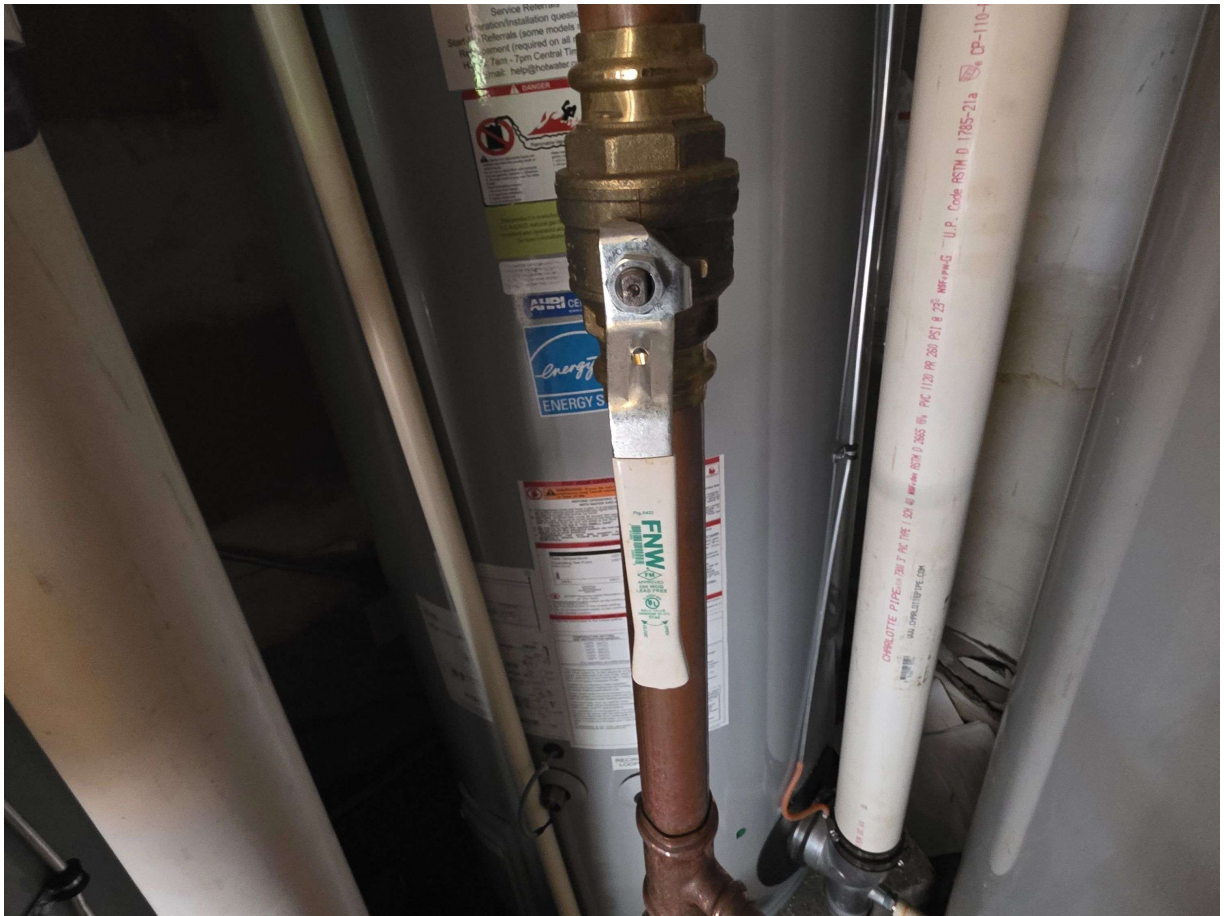
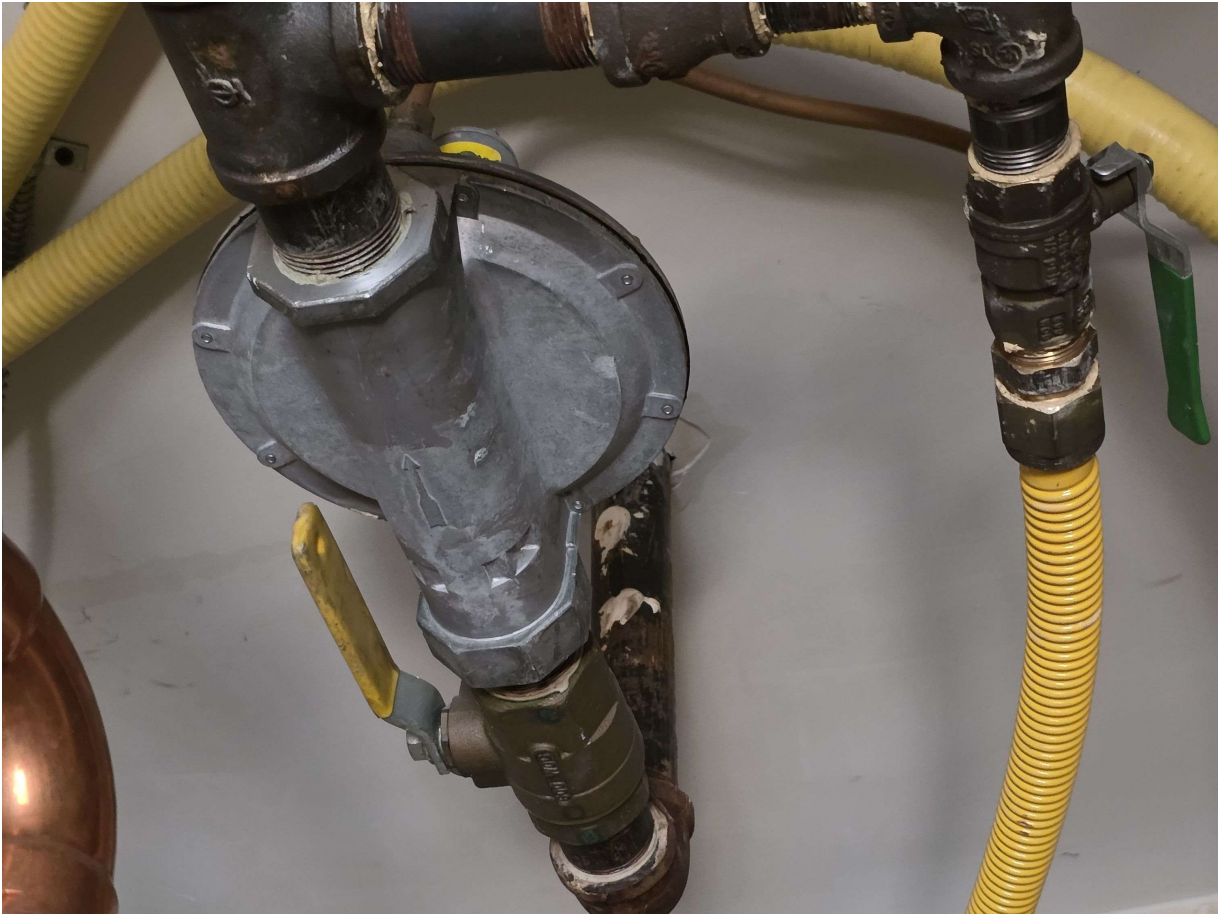
## Task: Valve check

| No. | Deficiency / Required Work | Field Condition / Scope | Virginia Code Assessment | Required Corrective Action / Verification | Code Reference | Deficiency Status |
|---|---|---|---|---|---|---|
| 4 | Missing vacuum relief valves | The water heaters/tanks are treated as bottom-fed and the required listed vacuum relief valves are missing. | Because the units are bottom-fed, the absence of ANSI Z21.22 vacuum relief valves does not comply with VPC Section 504.2. The installation also lacks the required approved means to prevent siphoning under Section 504.1. | Install a listed ANSI Z21.22 vacuum relief valve at the required upper-tank/cold-water location for each heater. Follow the approved design and manufacturer schematic and keep every valve accessible for inspection and service. | 2021 VPC 504.1 and 504.2; ANSI Z21.22; manufacturer instructions | MISSING / NONCOMPLIANT |

| 7 | Missing engineered backflow, check-valve and instrumentation design | An approved engineered layout is missing for the backflow preventer/check valves, isolation valves, unions, thermometers, pressure gauges and thermal-expansion control. Device locations and service/testing access have not been established. | The absence of an approved system design prevents verification of the required backflow protection, check-valve arrangement and downstream thermal-expansion control. The installation is treated as incomplete and noncompliant until the registered design professional establishes the required devices, locations and instrumentation. | The registered <b>design professional must issue the final design showing device types and locations, isolation valves/unions</b> , thermometers, pressure gauges, thermal-expansion control, testing access and service clearances. Install only after the design is approved and coordinated. | 2021 VPC 503.1, 607.3, 608 and 312.10; approved drawings/specifications; manufacturer instructions | MISSING / NONCOMPLIANT |

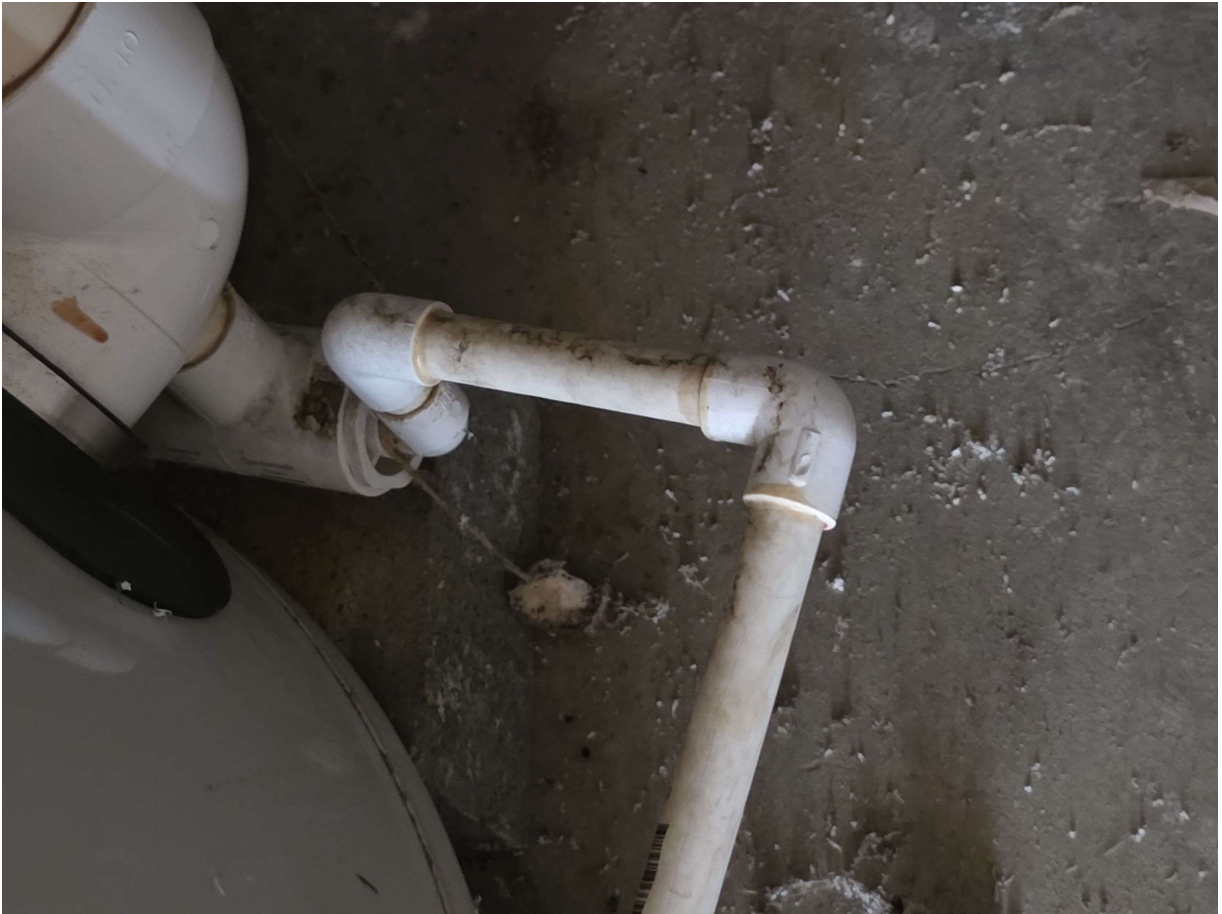
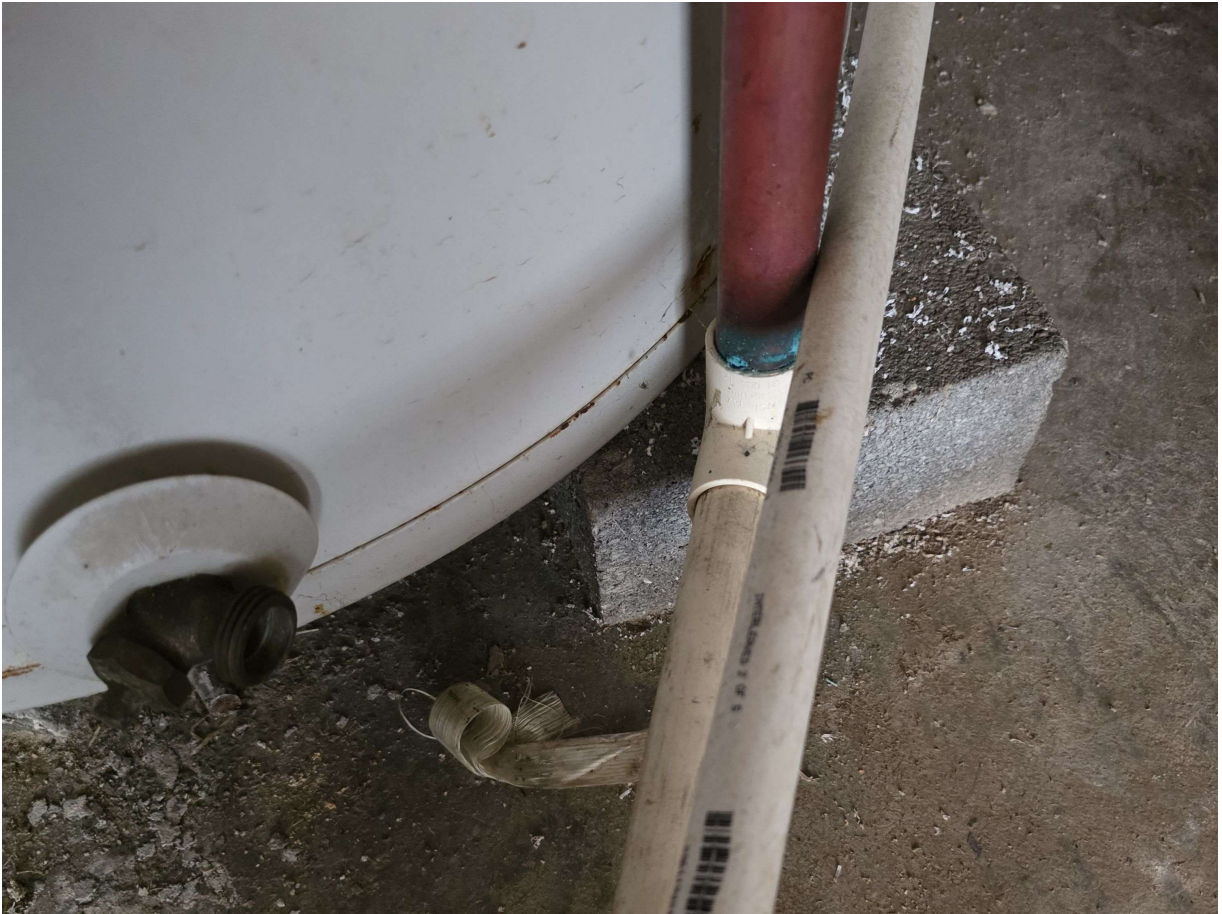
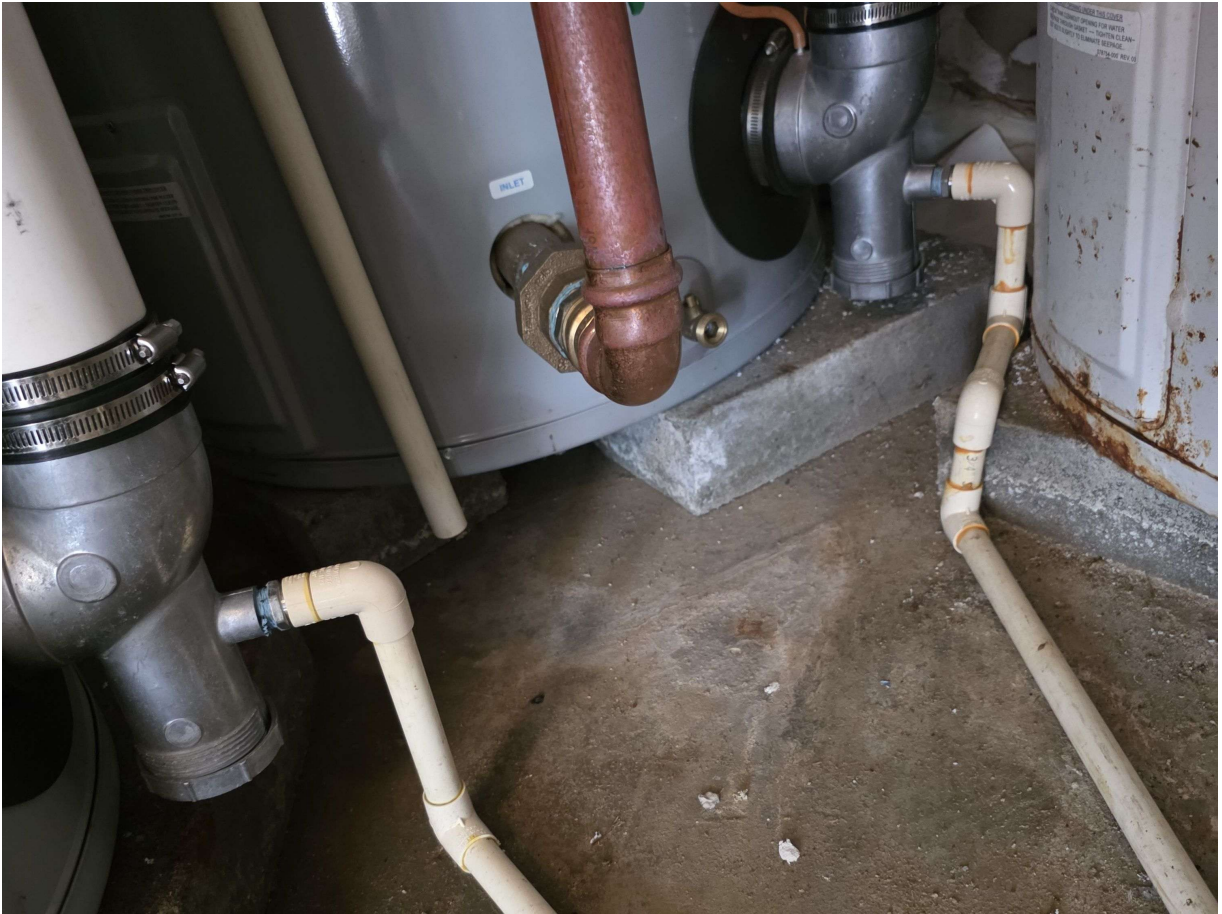
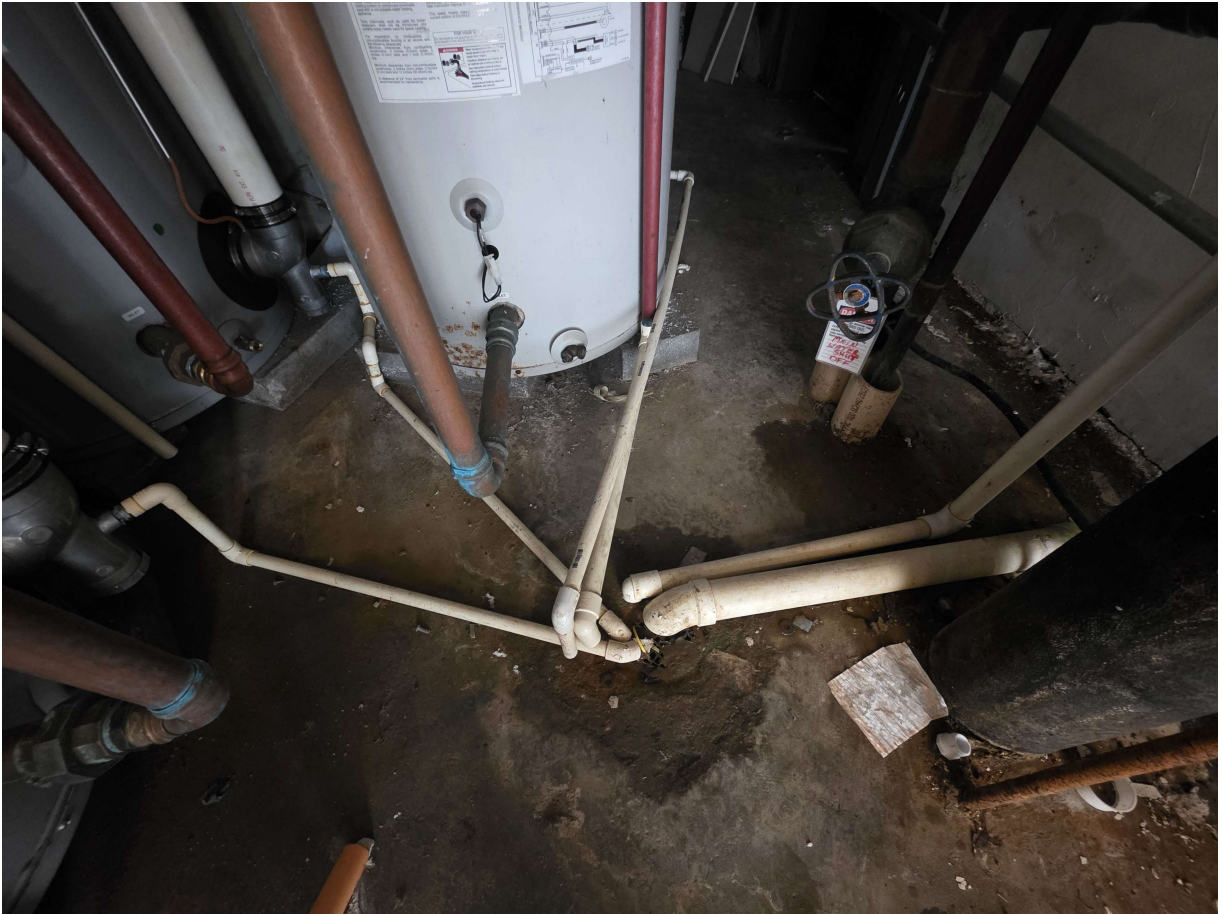
## Task: Check condensate pipes

| No. | Deficiency / Required Work | Field Condition / Scope | Virginia Code Assessment | Required Corrective Action / Verification | Code Reference | Deficiency Status |
|---|---|---|---|---|---|---|
| 6 | Missing condensate neutralization kits, routing and supports | Required condensate neutralizers are missing. Condensate piping does not reach an approved disposal point and lacks the complete slope, traps, indirect connection, access and associated supports. | For this report, the manufacturer/approved design and receiving drainage system are assumed to require condensate neutralization. The missing neutralizers and incomplete routing also fail the code requirements | Install manufacturer-approved neutralization kits for every condensing heater. Route condensate to an approved indirect receptor with the required trap and air gap/air break; provide continuous slope, accessible service points and all associated supports; test drainage and document neutralizer maintenance requirements. | 2021 VAFGC 307.2-307.4 and 624.1; 2021 VPC 308, 802 and 803; manufacturer instructions | MISSING / NONCOMPLIANT |
