## **DCMI Mid Atlantic Inc**

***6950 Nova Way, Manassas, VA***

### ***Sparks Hilton Electrical Assessment and Remediation Report***

**MEPD Project No. 2026102**

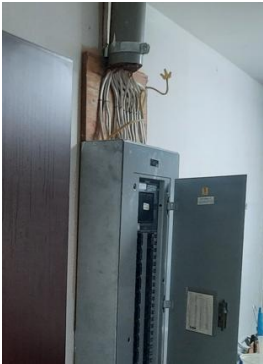
| Item | ROOM | PHOTOS | DEFICIENCY | CORRECTIVE ACTIONS |
|---|---|---|---|---|
| 1 | 3 <sup>RD</sup> FL LINEN | | Wires from panel hanging in the air. | Remove the wires from the panel. |

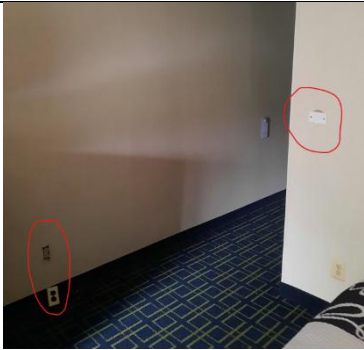
| 7 | Room 305 | | Thermostat is missing.<br>Receptacle plate is broken. | Install thermostat.<br>Install new receptacle plate. |

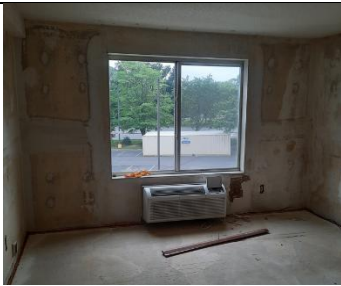
| 8 | Room 306 | | Room in renovation.<br>(cleaning, painting) | Shall be reinspected after renovation |

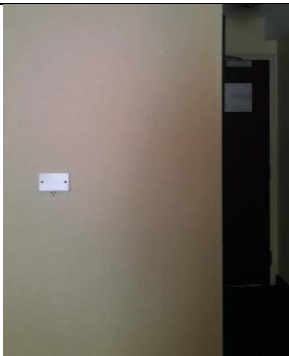
| 9 | Room 307 | | Thermostat is missing. Visible and accessible wires.<br>Receptacle in the bathroom non-GFI. | Install thermostat.<br>Install a GFI receptacle in the bathroom. |

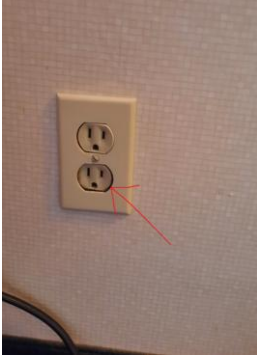
| 10 | Room 308 | | Receptacle improper installed | Reinstall the receptacles without gap between receptacle and plate |

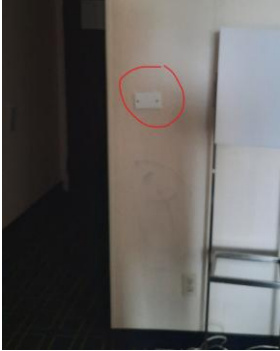
| 14 | Room 312 | | Thermostat is missing | Install thermostat |

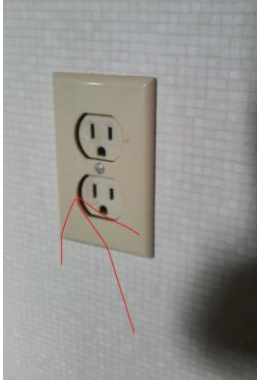
| 17 | Room 315 | | Receptacle improper installed | Reinstall the receptacles without gap between receptacle and plate |

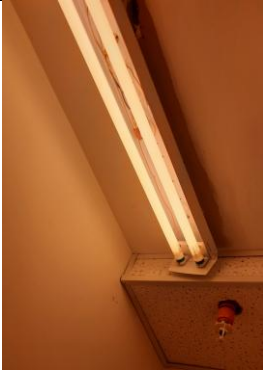
| 19 | 3 <sup>rd</sup> floor Linen Chute | | Light Fixture with missing lenses | Install lighting fixture lenses |

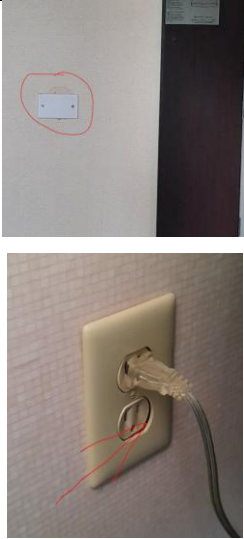
| 21 | Room 318 | | Thermostat is missing. Visible and accessible wires. Receptacle improper installed | Install thermostat. Reinstall the receptacles without gap between receptacle and plate |

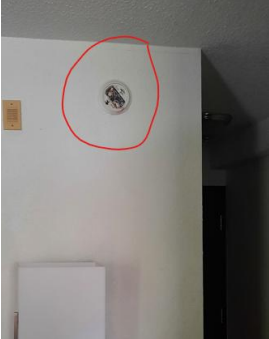
| 22 | Room 319 | | Smoke Detector is missing. | Install Smoke Detector |

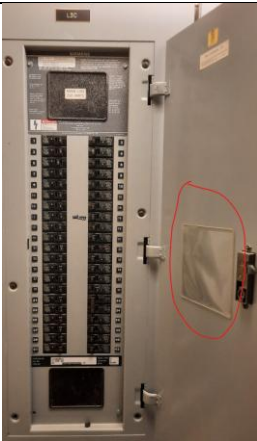
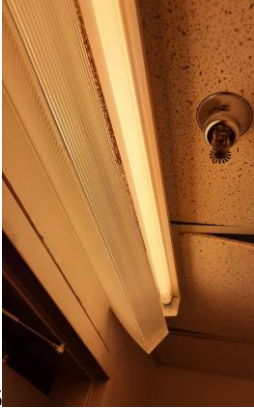
| 24 | 3 <sup>rd</sup> floor Electrical Room | <br> | <p>Panel L3C schedule is missing.</p> <p>Loose and improper supported wires.</p> <p>Lighting Fixture Lenses improper installed</p> | <p>Trace all circuits in the panel and create a panel schedule.</p> <p>Demolish all unused wired. The wires shall be supported withing 12" from the connectors.</p> <p>Install Lighting Fixture lenses.</p> |

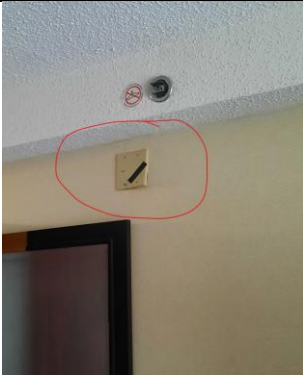
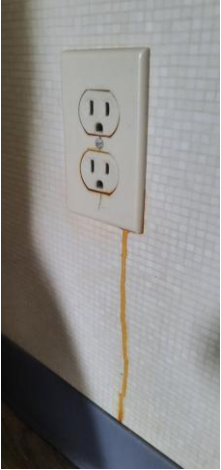
| 31 | Room 327 | | <p>Junction Box improper installed with broken cover.</p> <p>Thermostat is missing.</p> <p>Accessible wires</p> <p>Receptacle with water leakage traces</p> | <p>Reinstall the box and replace the cover.</p> <p>Install thermostat.</p> <p>Remove the receptacle and the box, verify if humidity is still present.</p> <p>Coordinate with the architect for fixing the leakage issue</p> |

| | | <br> | | prior installing a new receptacle with a new plate. |

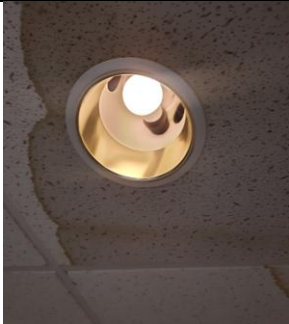
| 36 | 3 <sup>rd</sup> floor Hallway | | <p>Visible water stains due to roof leakage.</p> <p>Improper usage of the NM cable (Romex) above accessible ceiling.</p> <p>However the 3<sup>rd</sup> floor hallway is in renovation process and a new inspection shall be scheduled after the entire renovation is finished.</p> | <p>Coordinate with roof repairing contractors and replace the fixture if damaged.</p> <p>Above the accessible ceiling the use of Romex is not allowed by NEC. However, Romex could be used embedded in walls or in drywall ceiling. (not accessible spaces)</p> |

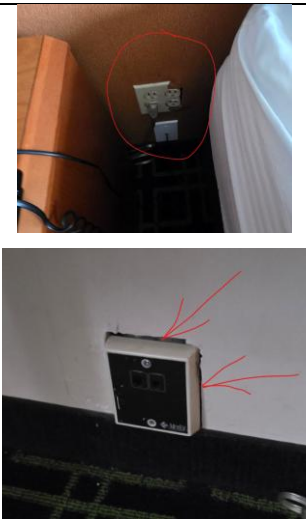
| 39 | Room 228 | | Receptacle with broken plate.<br><br>Improper installation of the data outlet with gap between the wall and outlet. | Replace receptacle plate.<br><br>Patch the wall and reinstall the receptacle. |

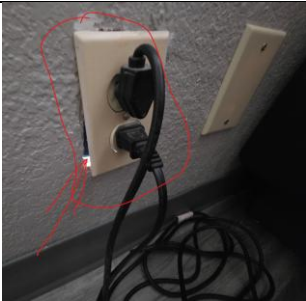
| 40 | Room 227 | | Receptacle improper installed. | Reinstall the receptacle and fix the drywall. |

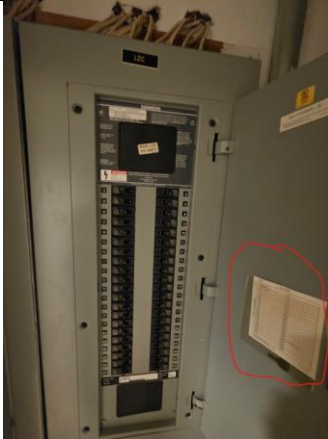
| 47 | 2 <sup>nd</sup> floor electrical room | | Panel L2C schedule is unreadable. | Trace all circuits in the panel and update the panel schedule. |

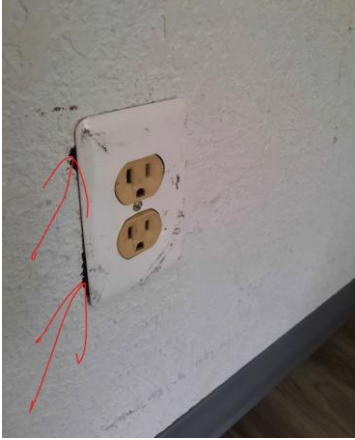
| 74 | Room 105 | | Improper face plate installation. | Remove and reinstall the receptacle to ensure it is securely fastened to the outlet box, properly supported, and installed flush with the finished wall. Replace the faceplate if damaged, ensuring there are no visible gaps between the faceplate and the wall surface. |

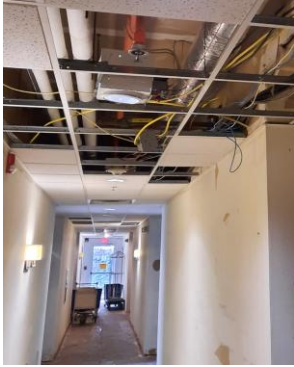
| 81 | 1 <sup>st</sup> floor hallway | | Improper usage of the NM cable (Romex) above accessible ceiling | Above the accessible ceiling the use of Romex is not allowed by NEC. However, Romex could be used embedded in walls or in drywall ceiling. (not accessible spaces) |

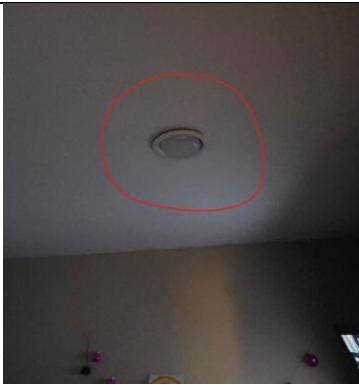
| 94 | 1 <sup>st</sup> floor office | | Light fixture trim improperly installed | Re-install the light fixture trim. |

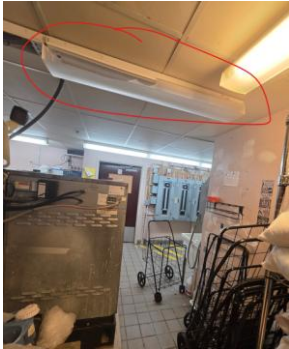
| 95 | 1 <sup>st</sup> floor Laundry | <br> | <p>Receptacle without GFI protection.</p> <p>Lighting Fixtures with broken lenses.</p> <p>Smoke detector improperly installed</p> | <p>Replace normal receptacles with GFI type.</p> <p>Replace the lenses for the lighting fixtures.</p> <p>Re-install the smoke detector.</p> |

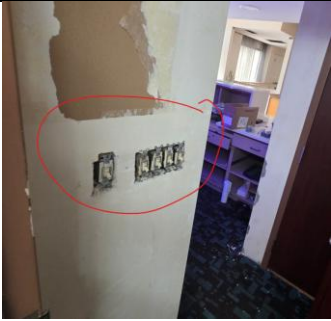
| 96 | 1 <sup>st</sup> floor reception | | Switches without face plates | Install faceplates for all switches. |

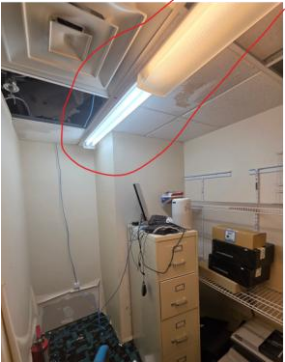
| 97 | 1 <sup>st</sup> floor office | | Lighting fixture without lenses. | Install protective lenses to match existing fixtures. |

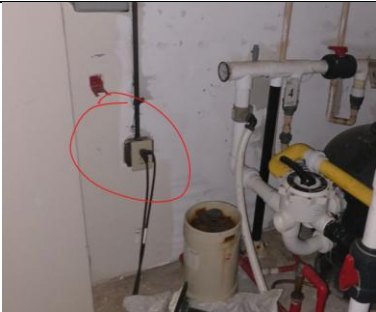
| 100 | 1 <sup>st</sup> floor pool equipment room | | Normal Receptacles installed.<br><br>Lighting Fixture without lenses | Replace the receptacles and the boxes with water proof GFI receptacles.<br><br>Install water proof lenses, or replace the fixture. |

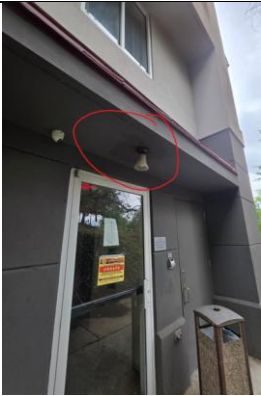
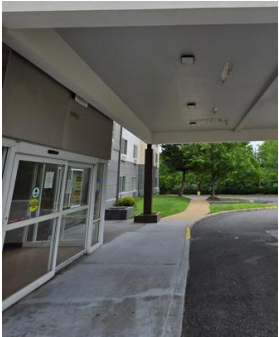
| 101 | Building exterior | | Exterior egress without emergency light | Install exterior emergency lights. | |
| 102 | Building exterior | | Feeder exposed and un-protected. | Change the wiring system and protect the exposed feeder. | |
| 103 | Building exterior | | Exterior egress without emergency light | Install exterior emergency lights with battery backup | |
